# **MARIN COUNTY STREAM CROSSING INVENTORY AND FISH PASSAGE EVALUATION**

## **FINAL REPORT**

**Prepared for the County of Marin – Department of Public Works**

**July 2003**

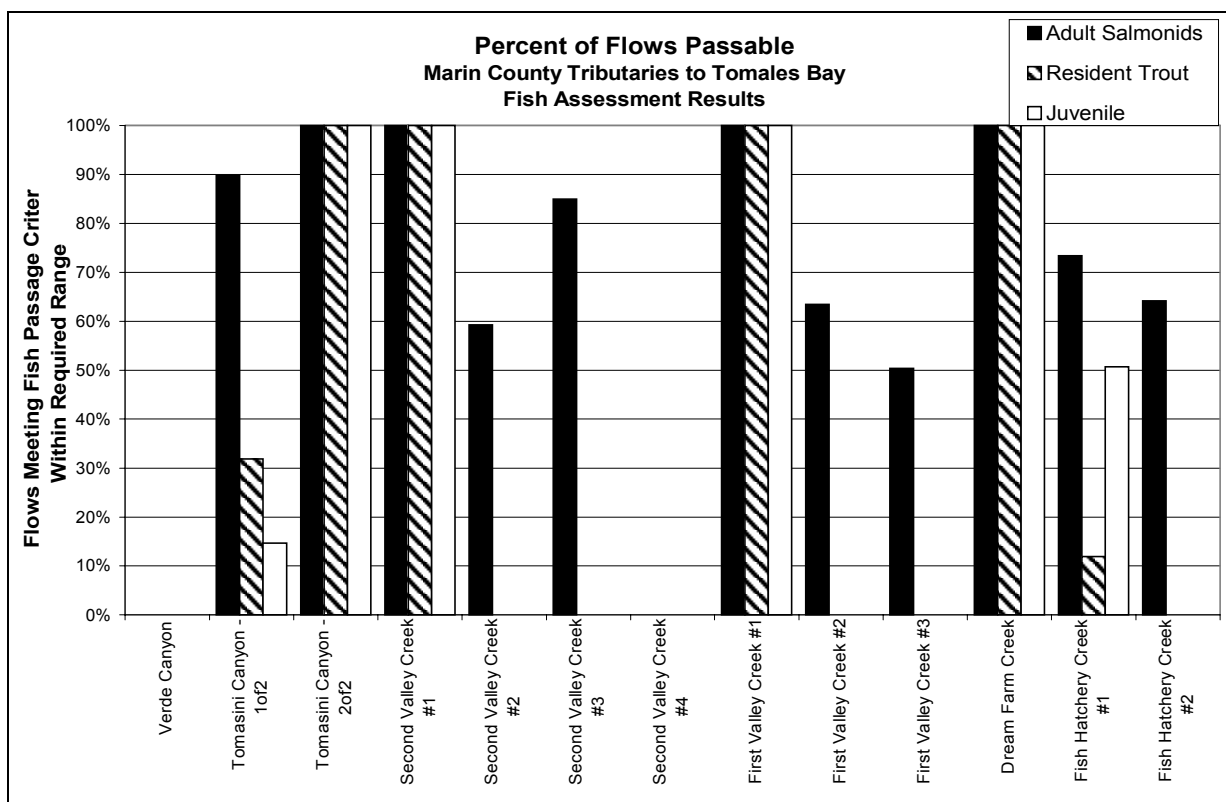
Figure 7. Percent passable as estimated by the Green-Gray-Red evaluation filter and FishXing for 12 Marin County stream crossings within tributaries of the Tomales Bay sub-watershed, by three groups of life stages.

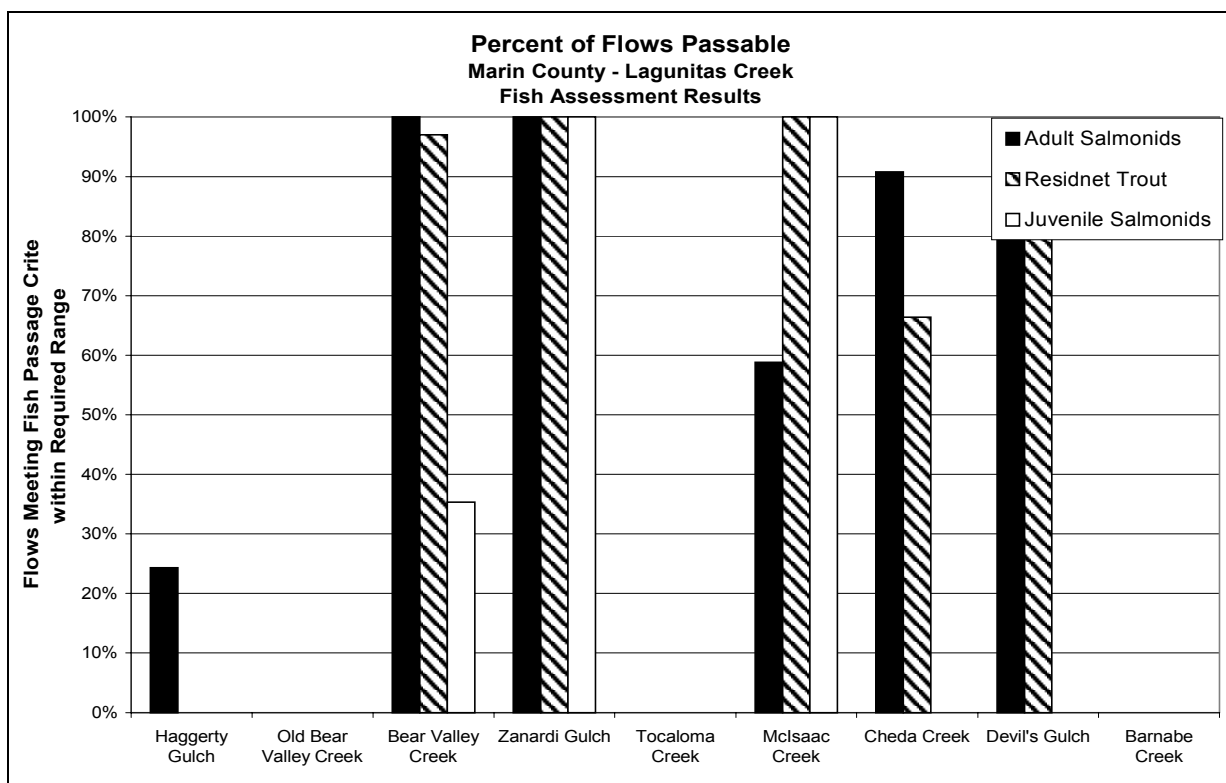
Figure 8. Percent passable as estimated by the Green-Gray-Red evaluation filter and FishXing for nine Marin County stream crossings within tributaries of Lagunitas Creek, by three groups of life stages.

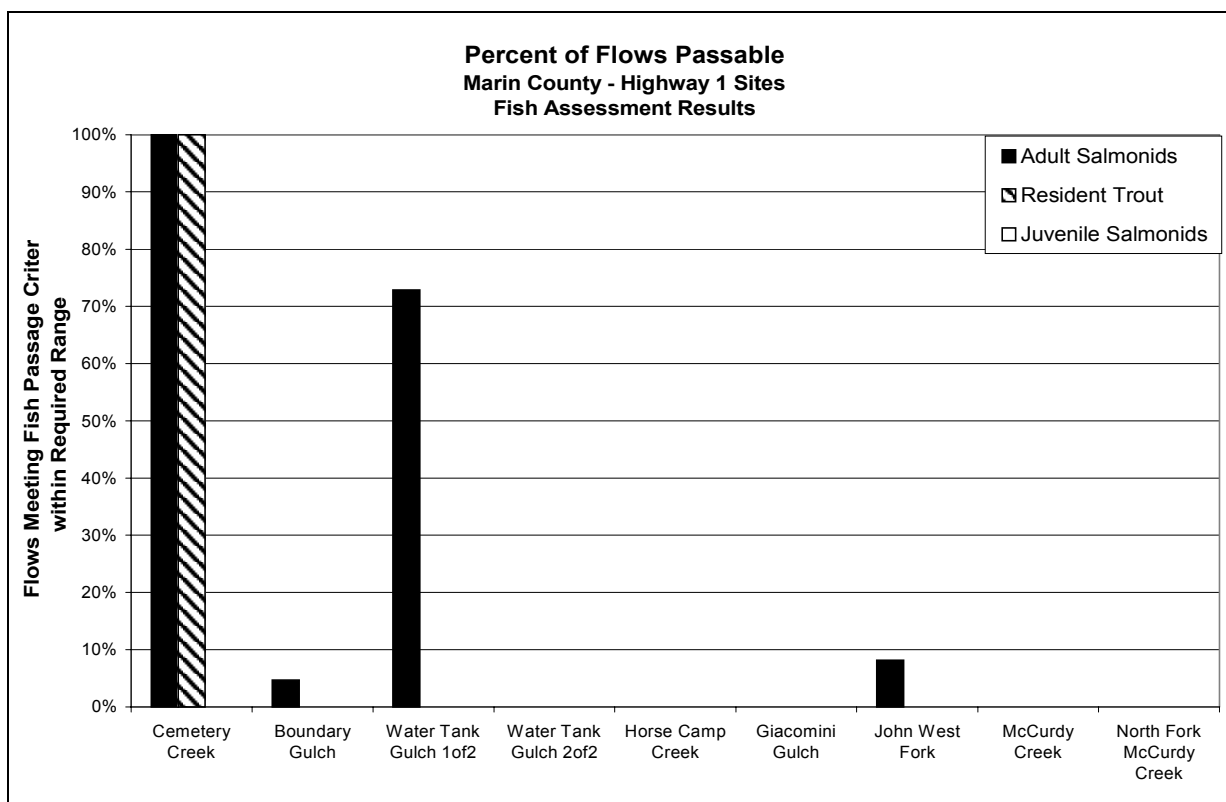
**Figure 9.** Percent passable as estimated by FishXing for eight Marin County stream crossings located on Highway One on tributaries to Olema Creek and Pine Creek, by three groups of life stages.

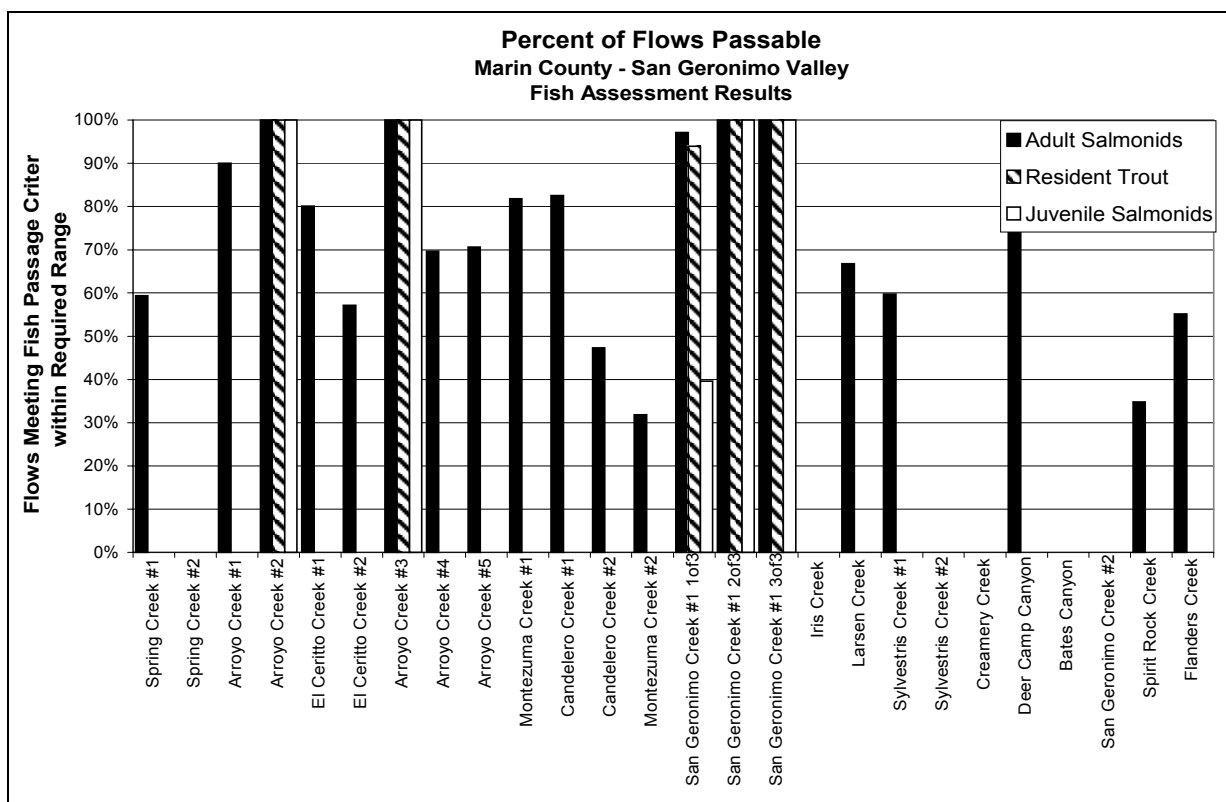
**Figure 10.** Percent passable as estimated by FishXing for 24 Marin County stream crossings within the San Geronimo sub-basin of the Lagunitas Creek watershed, by three groups of life stages.

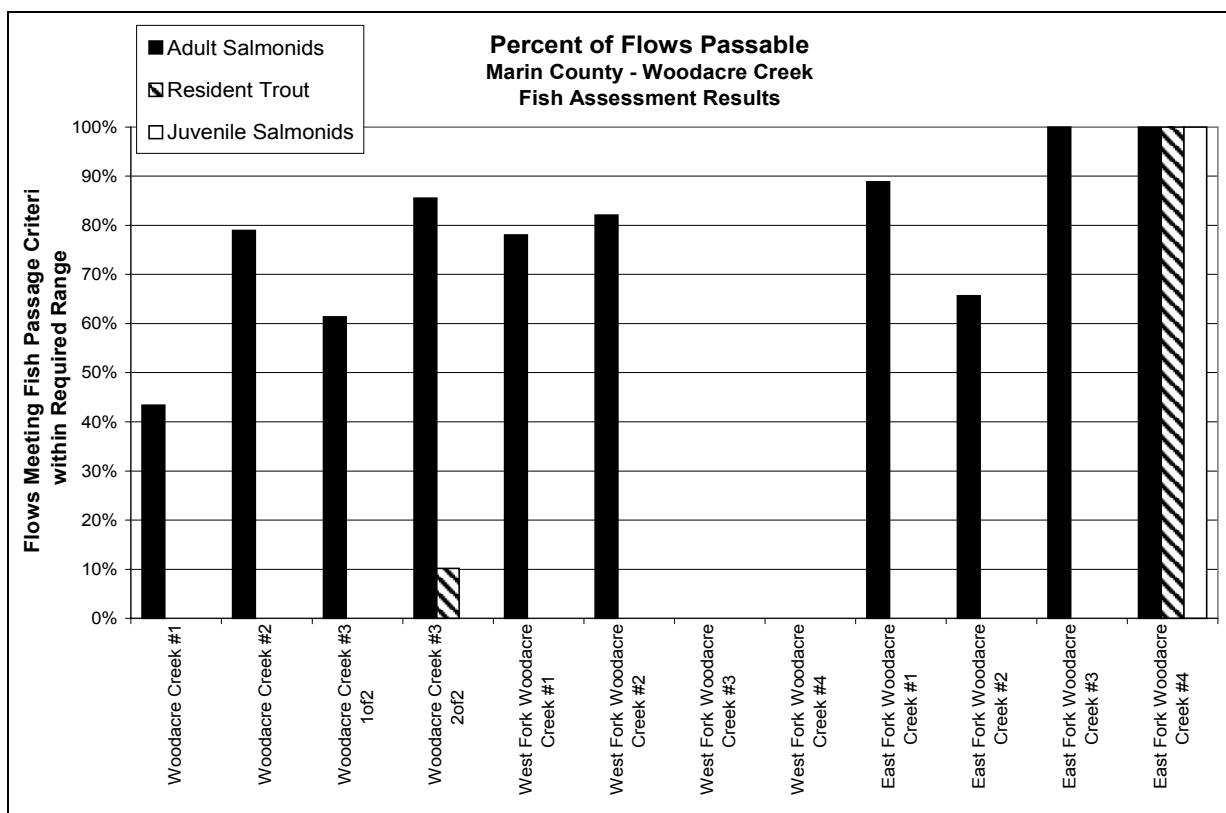
Figure 11. Percent passable as estimated by FishXing for 11 Marin County stream crossings within the Woodacre Creek sub-basin of the Lagunitas Creek watershed, by three groups of life stages.

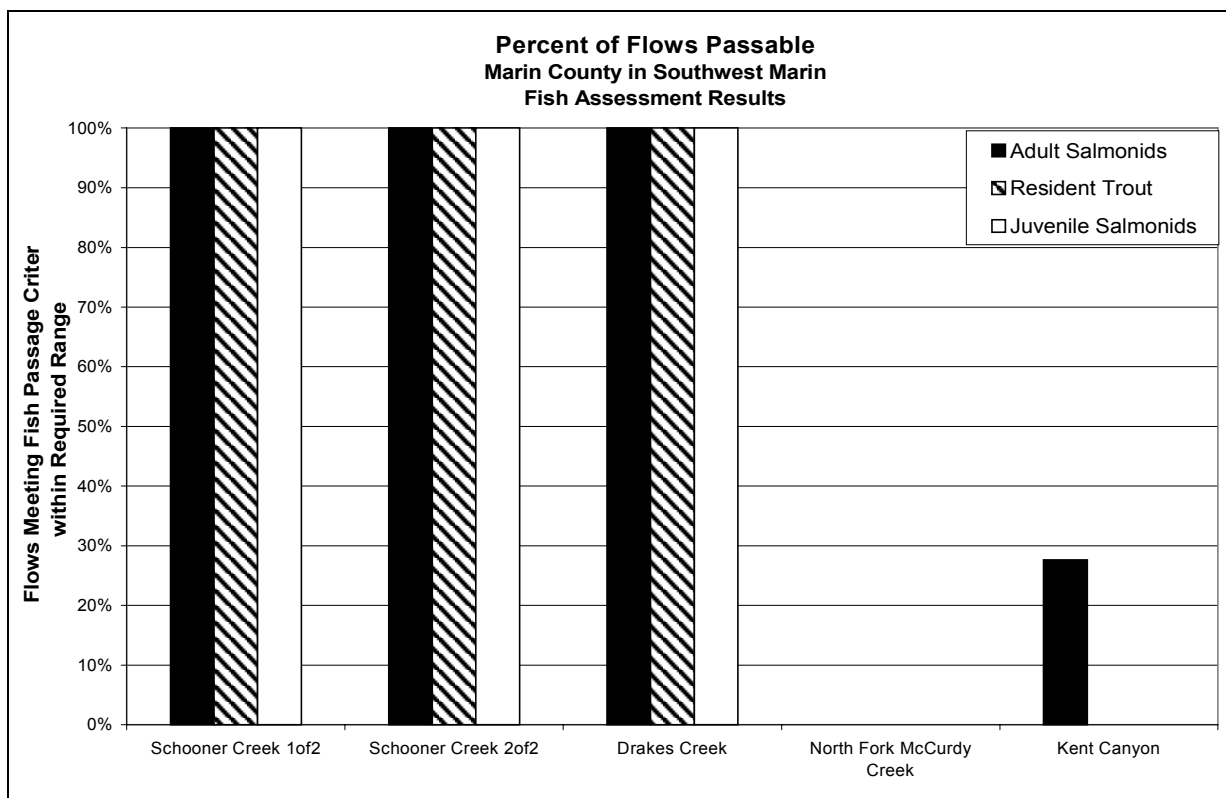
Figure 12. Percent passable as estimated by FishXing for four Marin County stream crossings on tributaries located in southwestern Marin County, by three groups of life stages.

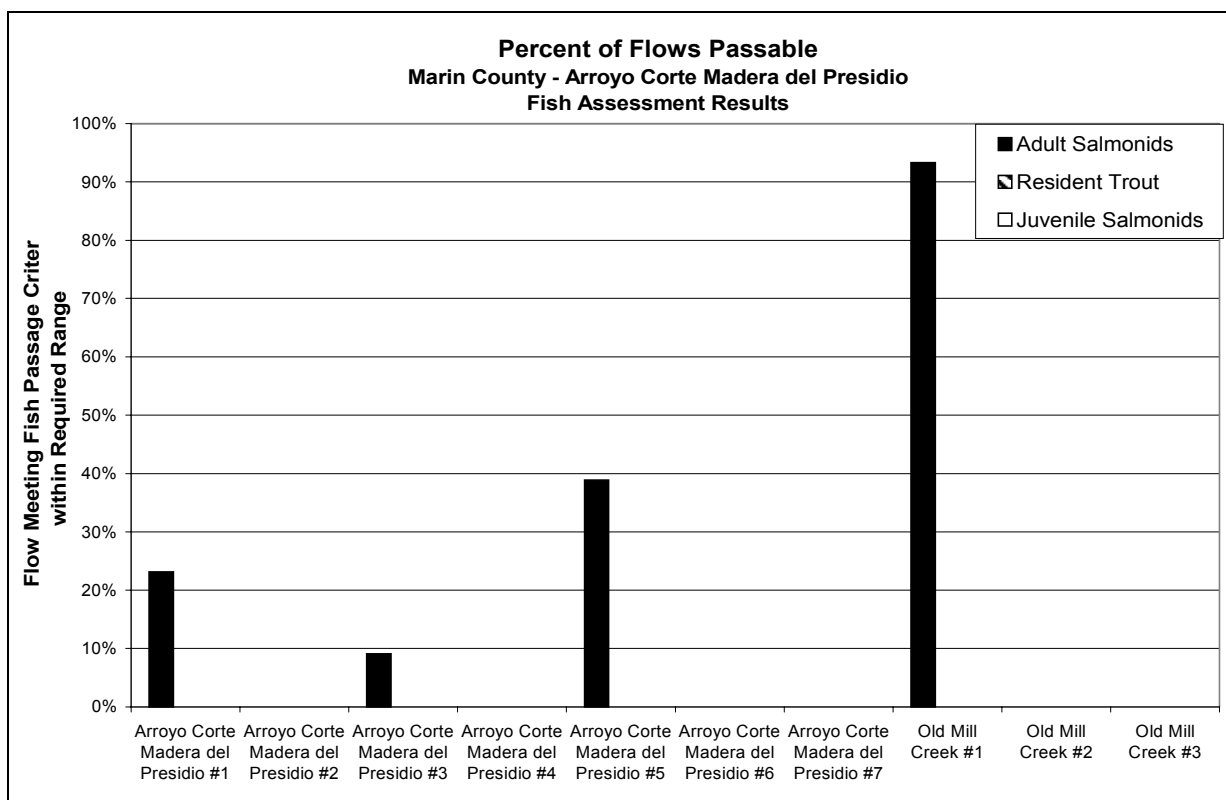
**Figure 13. Percent passable as estimated by FishXing for 10 Marin County stream crossings within the Arroyo Corte Madera del Presidio watershed, by three groups of life stages.**

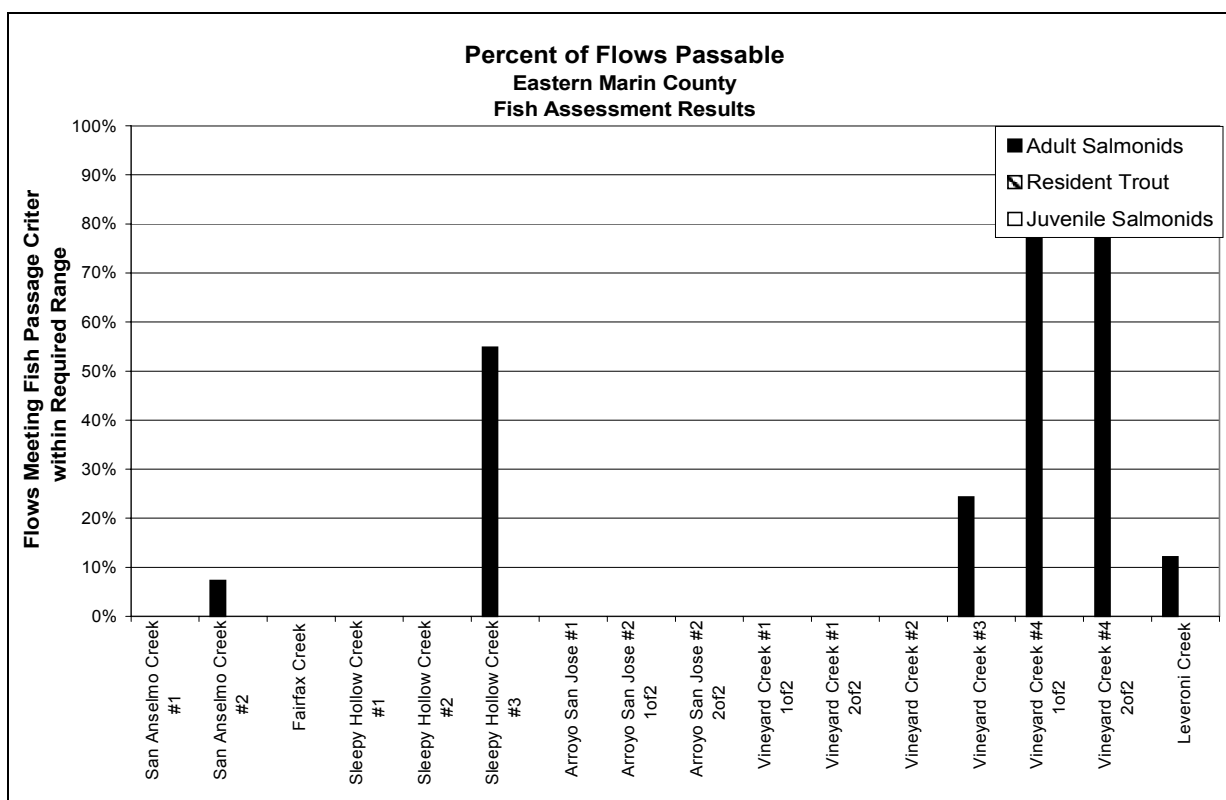
**Figure 14. Percent passable as estimated by FishXing for 13 Marin County stream crossings within eastern Marin County watershed, by three groups of life stages.**
