Conner Creek Migration Barrier Removal Project

Conner Creek Road – Conner Creek - November 2011

CA DEPARTMENT OF FISH AND GAME AGREEMENT P0710308 FINAL REPORT

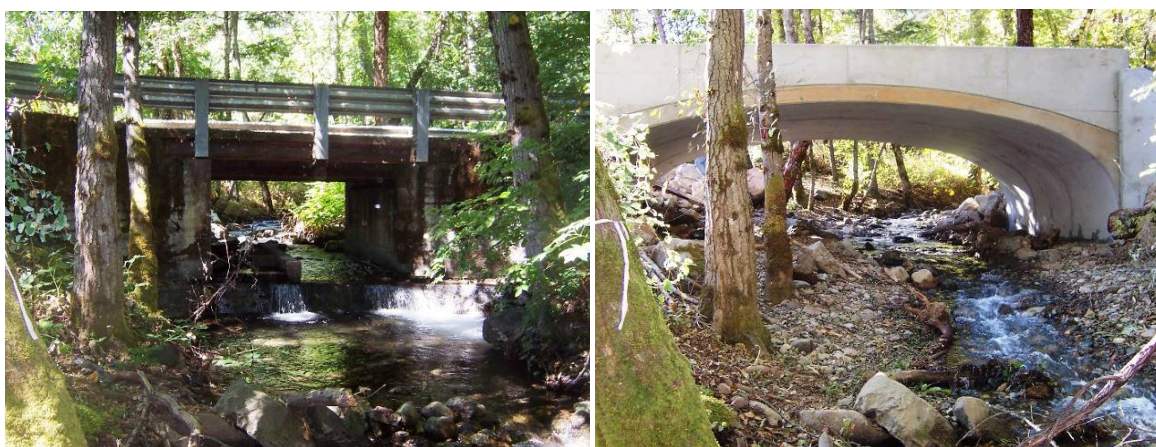
Conner Creek Road Project Before with 10' concrete box culvert looking upstream (left) and restored channel with 24' wide bridge (right).

The Conner Creek Road design, however, required scrapping the original plan. The new design was completed by Trinity County Department of Transportation (TCDOT) Engineer Wes Scribner, with assistance from Randy Cessna and Director Rick Tippet, and in consultation with 5C Staff and NOAA Fisheries Engineer Margaret Tauzer. The crossing was designed with full stream simulation with a 24-foot span, 16' wide precast concrete ConSpan bridge set on poured-in-place footings and abutments. The project included the removal of the concrete box, the reconstruction of the channel at a gradient of 6% or less with jumps of less than 6" in height to support juvenile migration, and grade control rock ribbons set below the channel grade.

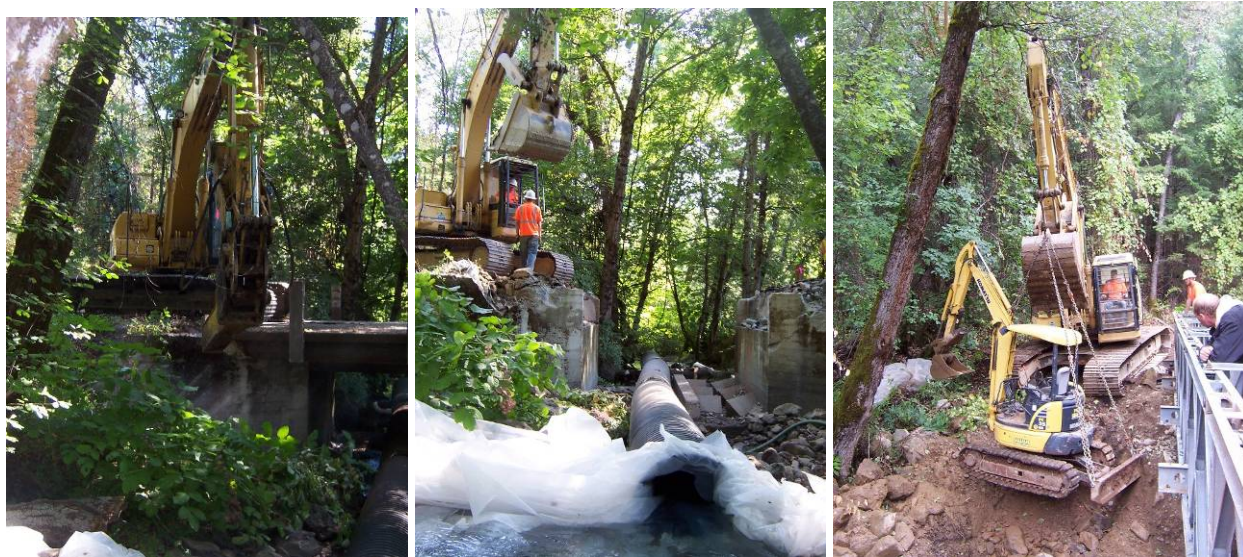
Removing culvert and deck (left and middle), and lowering a small excavator to work under the detour bridge to dig footing and the new stream channel and floodplain areas.

To accomplish that goal the Trinity County DOT utilized a Bailey Bridge and a rented 320 Cat excavator to work in tandem with their own 320 Cat excavator. They also rented a small excavator that could be lowered into the stream channel and work under the Bailey Bridge. The approaches on the Bailey Bridge were ramped up 2' to give room for equipment to work under it. These approaches provided the maneuverability and long reaches needed to work from the road surface, minimizing the project footprint area.

In a single day the deck of the existing box culvert was removed intact using the two large excavators and the Bailey Bridge was installed adjacent to the now open box culvert. From that day until October 31st residents used the Bailey Bridge detour around the worksite. The walls and floor of the concrete box were pneumatically hammered into pieces and end hauled to a disposal area. In order to protect tree trunks during portions of the work, a series of guys were

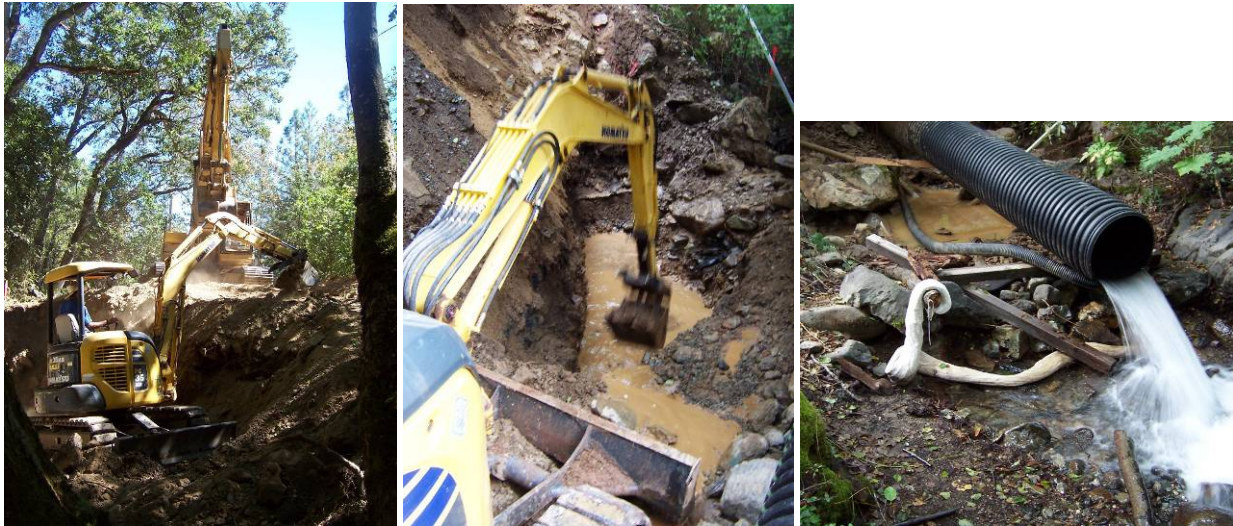
Excavating channel (left) and footings (middle) and water quality protections during jetting, which created the most turbid water conditions (right).

Based on the geotechnical investigation (Taber Consulting), both the soil and rocky material found at the site are capable of supporting bridge footings without distress. Based on ConTech's engineering recommendations, footings were excavated 3 feet deep and approximately 4 feet wide. The footings assure structural stability for the concrete abutments. After each footing was excavated, a concrete truck either used a chute or a pump to fill the footing excavation. After each abutment was formed/framed, a concrete pump truck was used to pump directly into the forms. Due to the weight limitations of the detour bridge, it was not possible to use a chute to directly fill the forms from the truck. Each abutment was backfilled with a compacted mix of 3" minus and native rock while they cured for about 2 weeks. During this time in-stream work continued including excavation to form the new channel and set it at the desired gradient. The final rock ribbons were in place and the streambed was completed by October 26. The detour bridge was removed and the new precast ConSpan bridge and wing walls were lifted into place on October 29, 2011. The new bridge was mortared into place and the wing wall and abutment were backfilled and compacted.

The remaining roughened channel consists of three rock ribbon grade-control structures constructed with 1-2 ton rock, buried 2 layers deep and keyed together and into the banks. Engineered streambed material designed to be stable up to the 100-year flows was placed in the channel (refer to Attachment 1 for the calculated streambed mix) and jetted to compaction using a Honda WH20 pump with a ¼ smooth bore nozzle. During jetting, turbid water was pumped from the lower end of the project and recirculated into the jetted material. A non-woven geo-fabric dam trapped fine sediment and constant pumping of the lower end of the project removed turbid water before it could re-enter the stream.

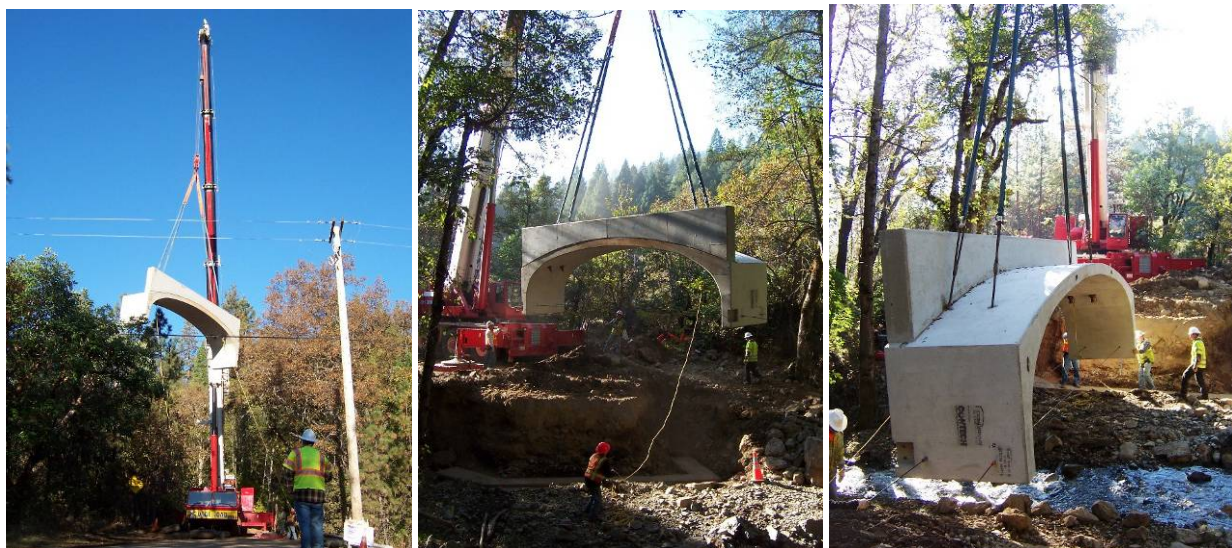
Above Placing the ConSpan arches on the footings

Once the streambed gradient was set and the footing forms removed, the Bailey Bridge was removed and the actual bridge structure was placed. To place the bridge a 100 ton crane was mobilized to the site the day before placement and the structures arrived the next morning. The entire project was completed in a matter of hours and the road re-opened.

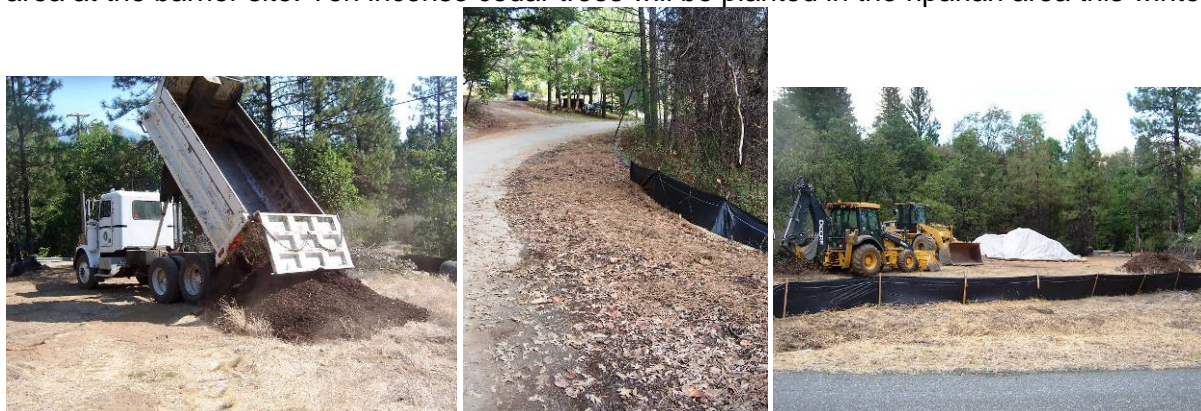
Organic compost (left) and native pine needle mulch (middle) were applied and water quality BMP's applied (right).

On November 1st the site final erosion control and temporary reseeding effort was completed. 10 pounds of native grass (Blue Wild Rye: (*Elymus glaucus*), Meadow Barley: (*Hordeum Brachyantherum*), Beardless Wild Rye (*Leymus Triticoides*) was planted and mulched with native mulch/compost provided by TCDOT in October and November. Seed was purchased by the Trinity County Resource Conservation District (RCD) and was a locality mix. Seeded portions included sections of Conner Creek road north of the bridge that were disturbed during construction as well as all disturbed soil along Conner Creek, the riparian area and the staging area at the barrier site. Ten incense cedar trees will be planted in the riparian area this winter.

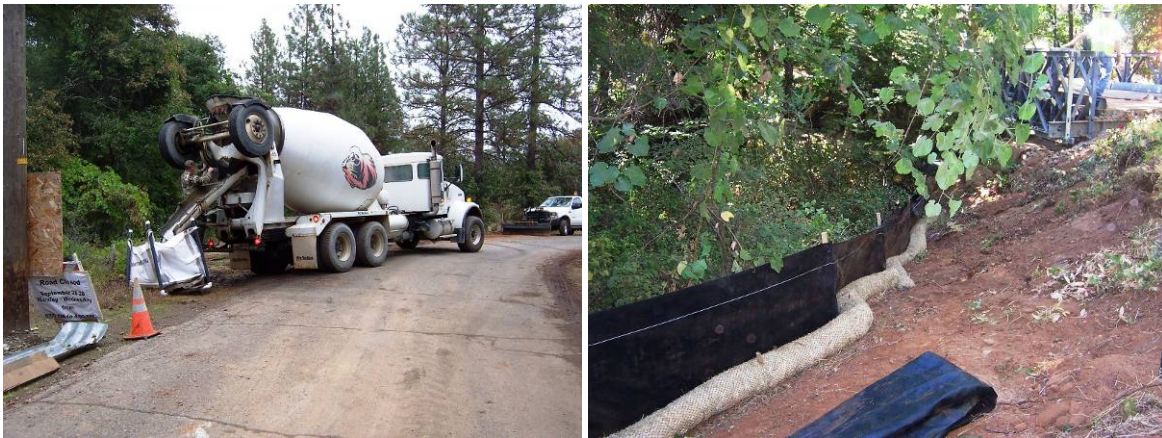
Above left concrete washout stations were required and riparian sediment fencing and silt waddles in place (right)
