Klamath Tributary Fish Passage Improvement Project

2012-2013 Field Season Results

Objectives of Project

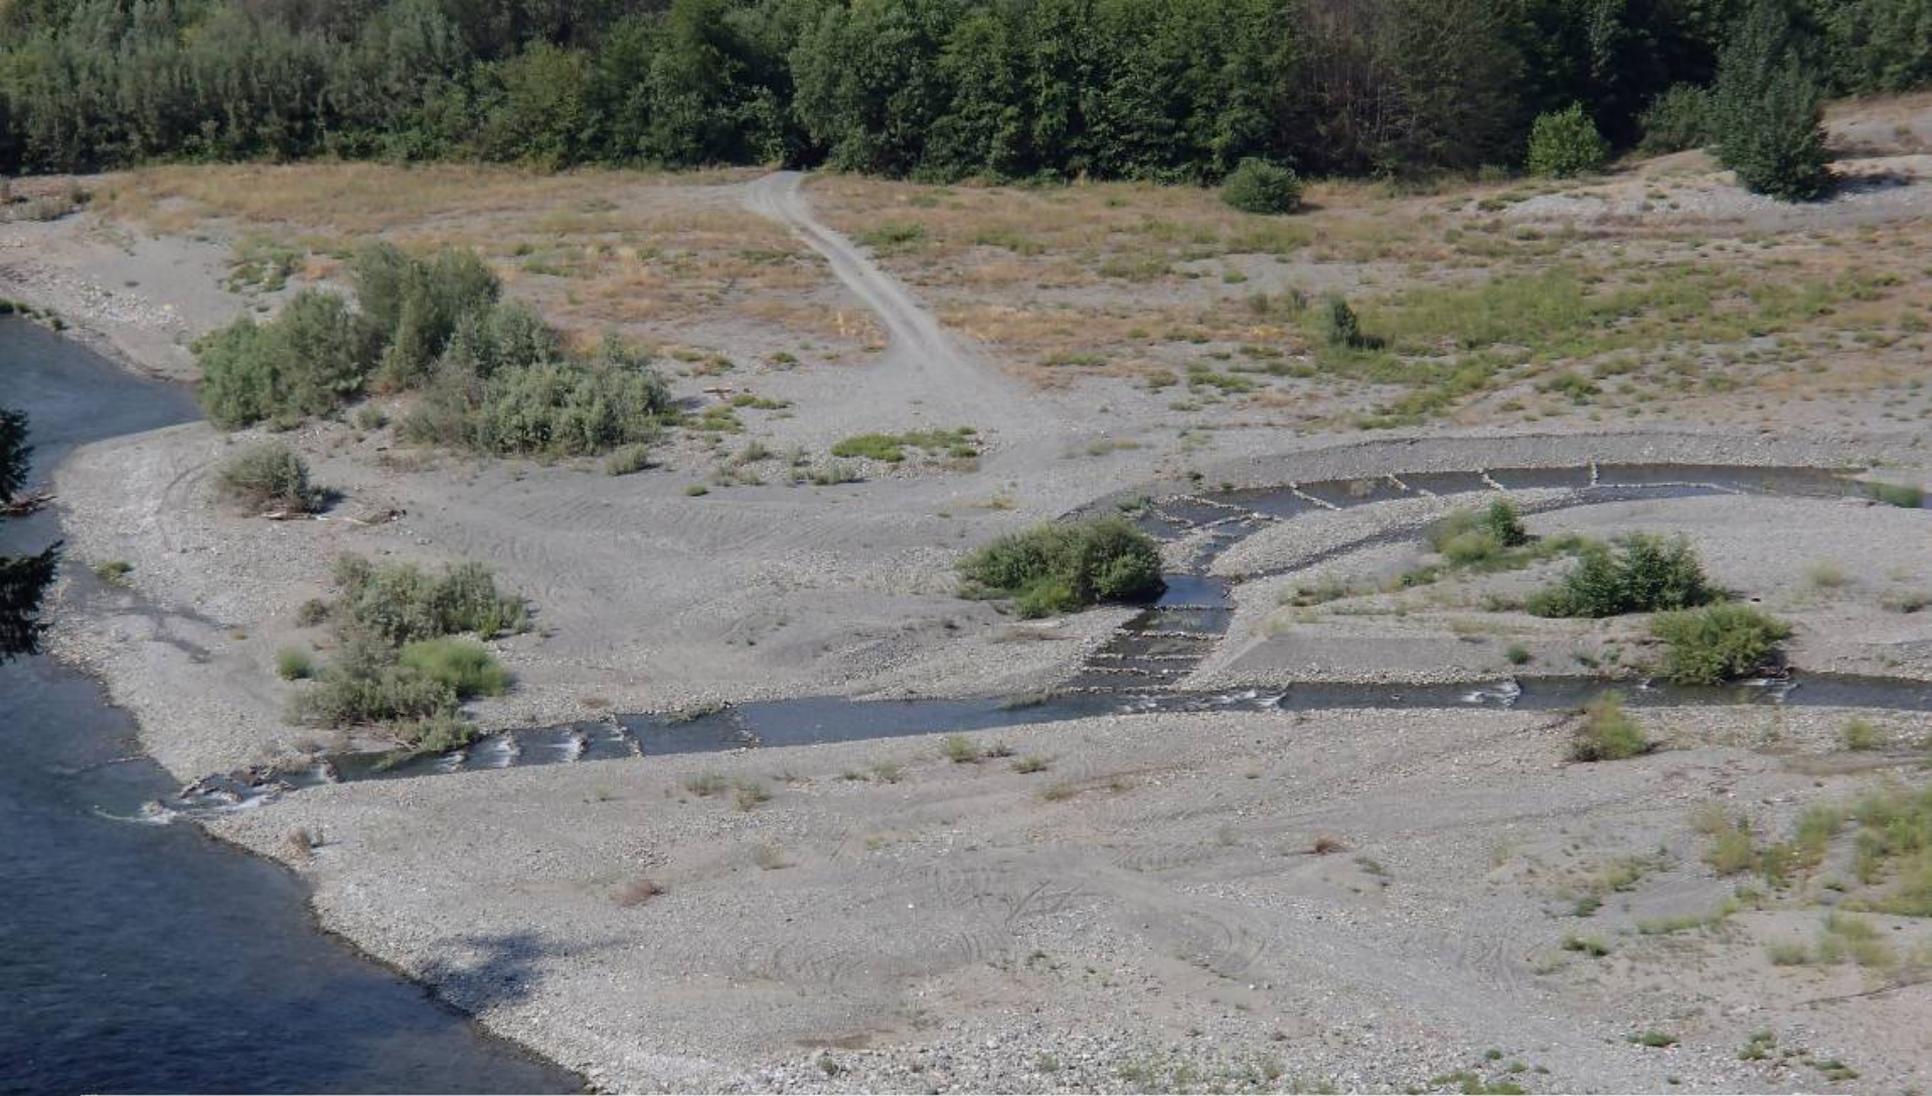
In the winter of 2005, the Camp Creek channel shifted below the Highway 96 bridge, abandoning its old, well-shaded course (at top of above photo) onto ½ mile of bare alluvial delta. The lower ¼ mile of Camp Creek settles into a new configuration each spring and presents a new challenge for maintaining fish passage, not to mention maintaining reasonable stream temperatures. By consolidating flows and creating depth and structure with step and pool fishways and brush bundles, MKWC can ensure juvenile and adult fish passage, cover complexity and favorable temperatures throughout the summer and fall.

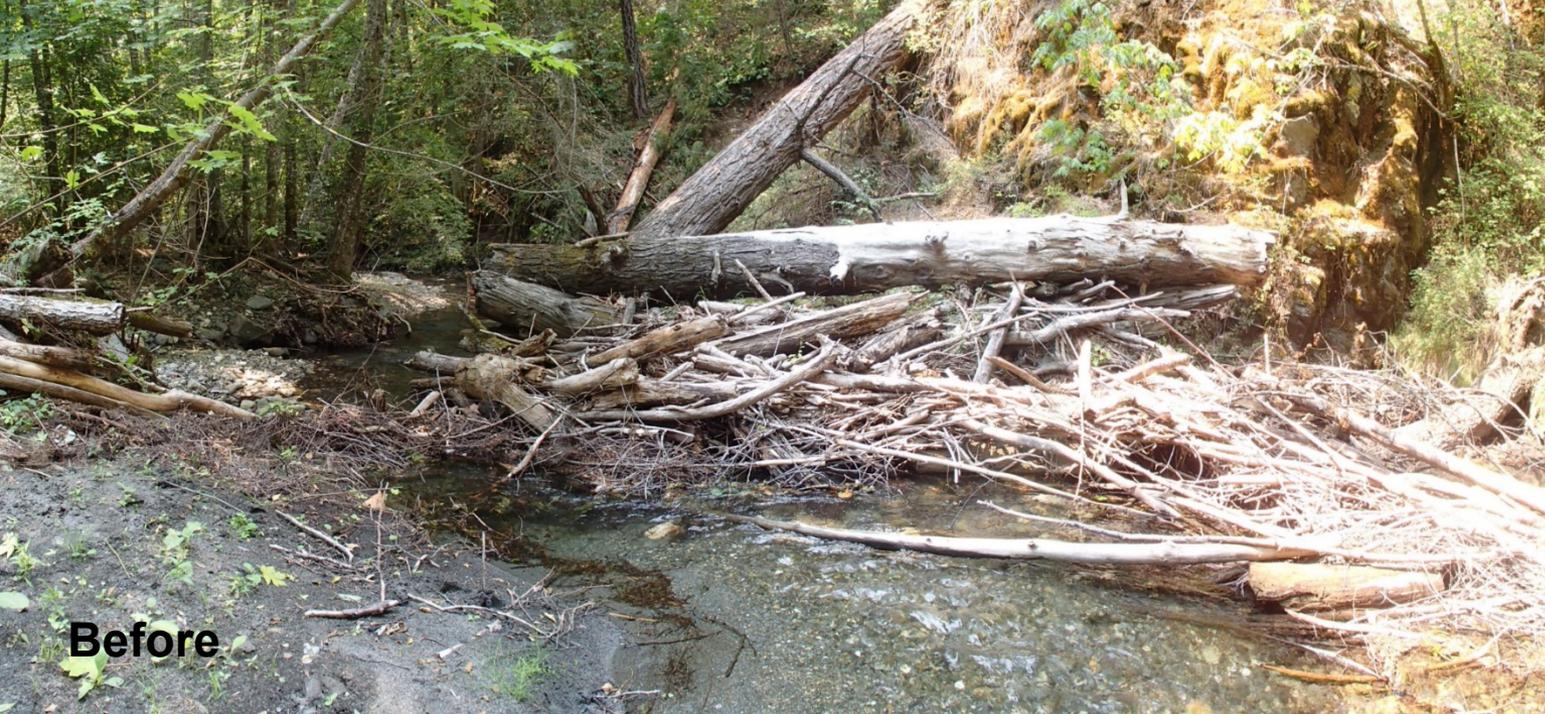
Before

Horse Creek
Fish Passage
Summer 2013

Manually
breaching a log
jam for adult and
juvenile fish
passage

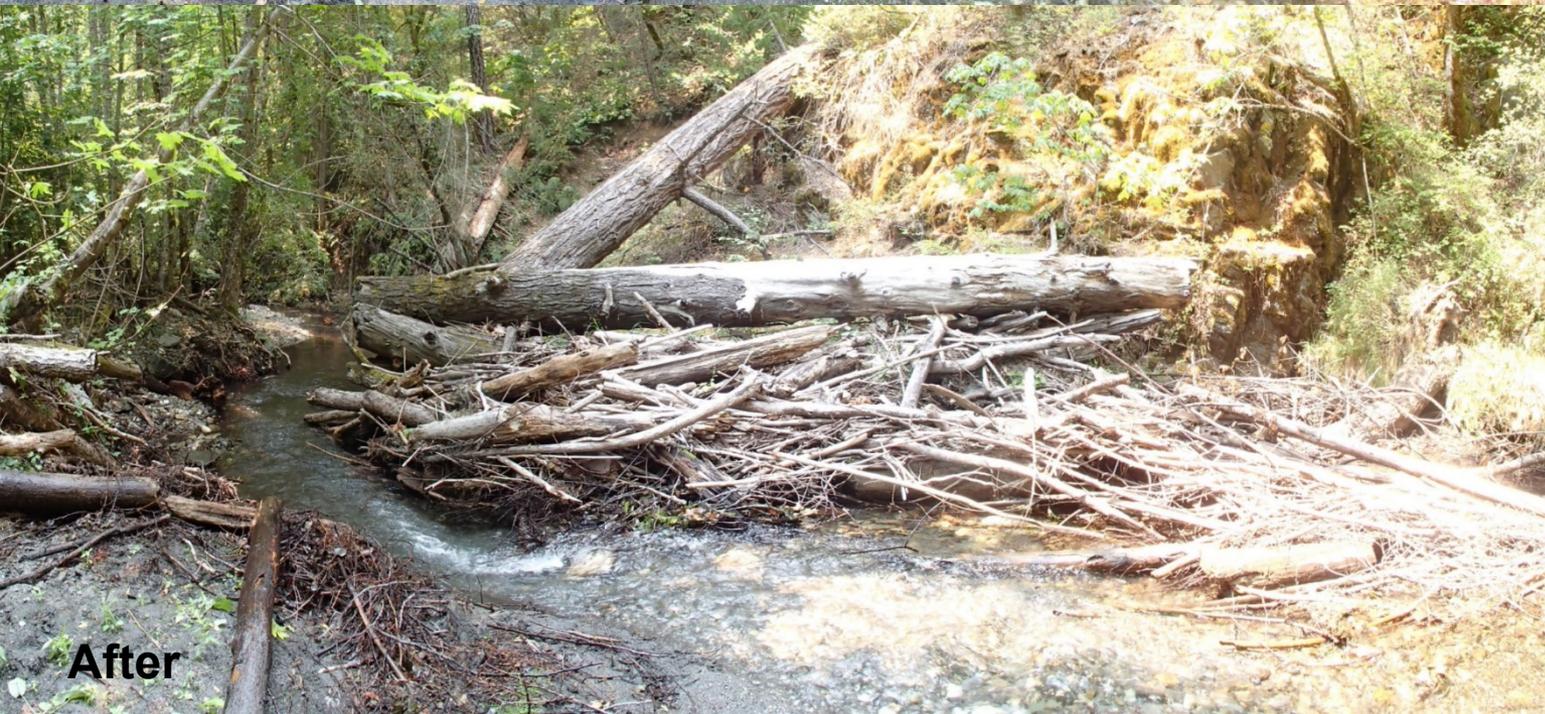
After

Juvenile and
adult coho found
above log jam
after treatment

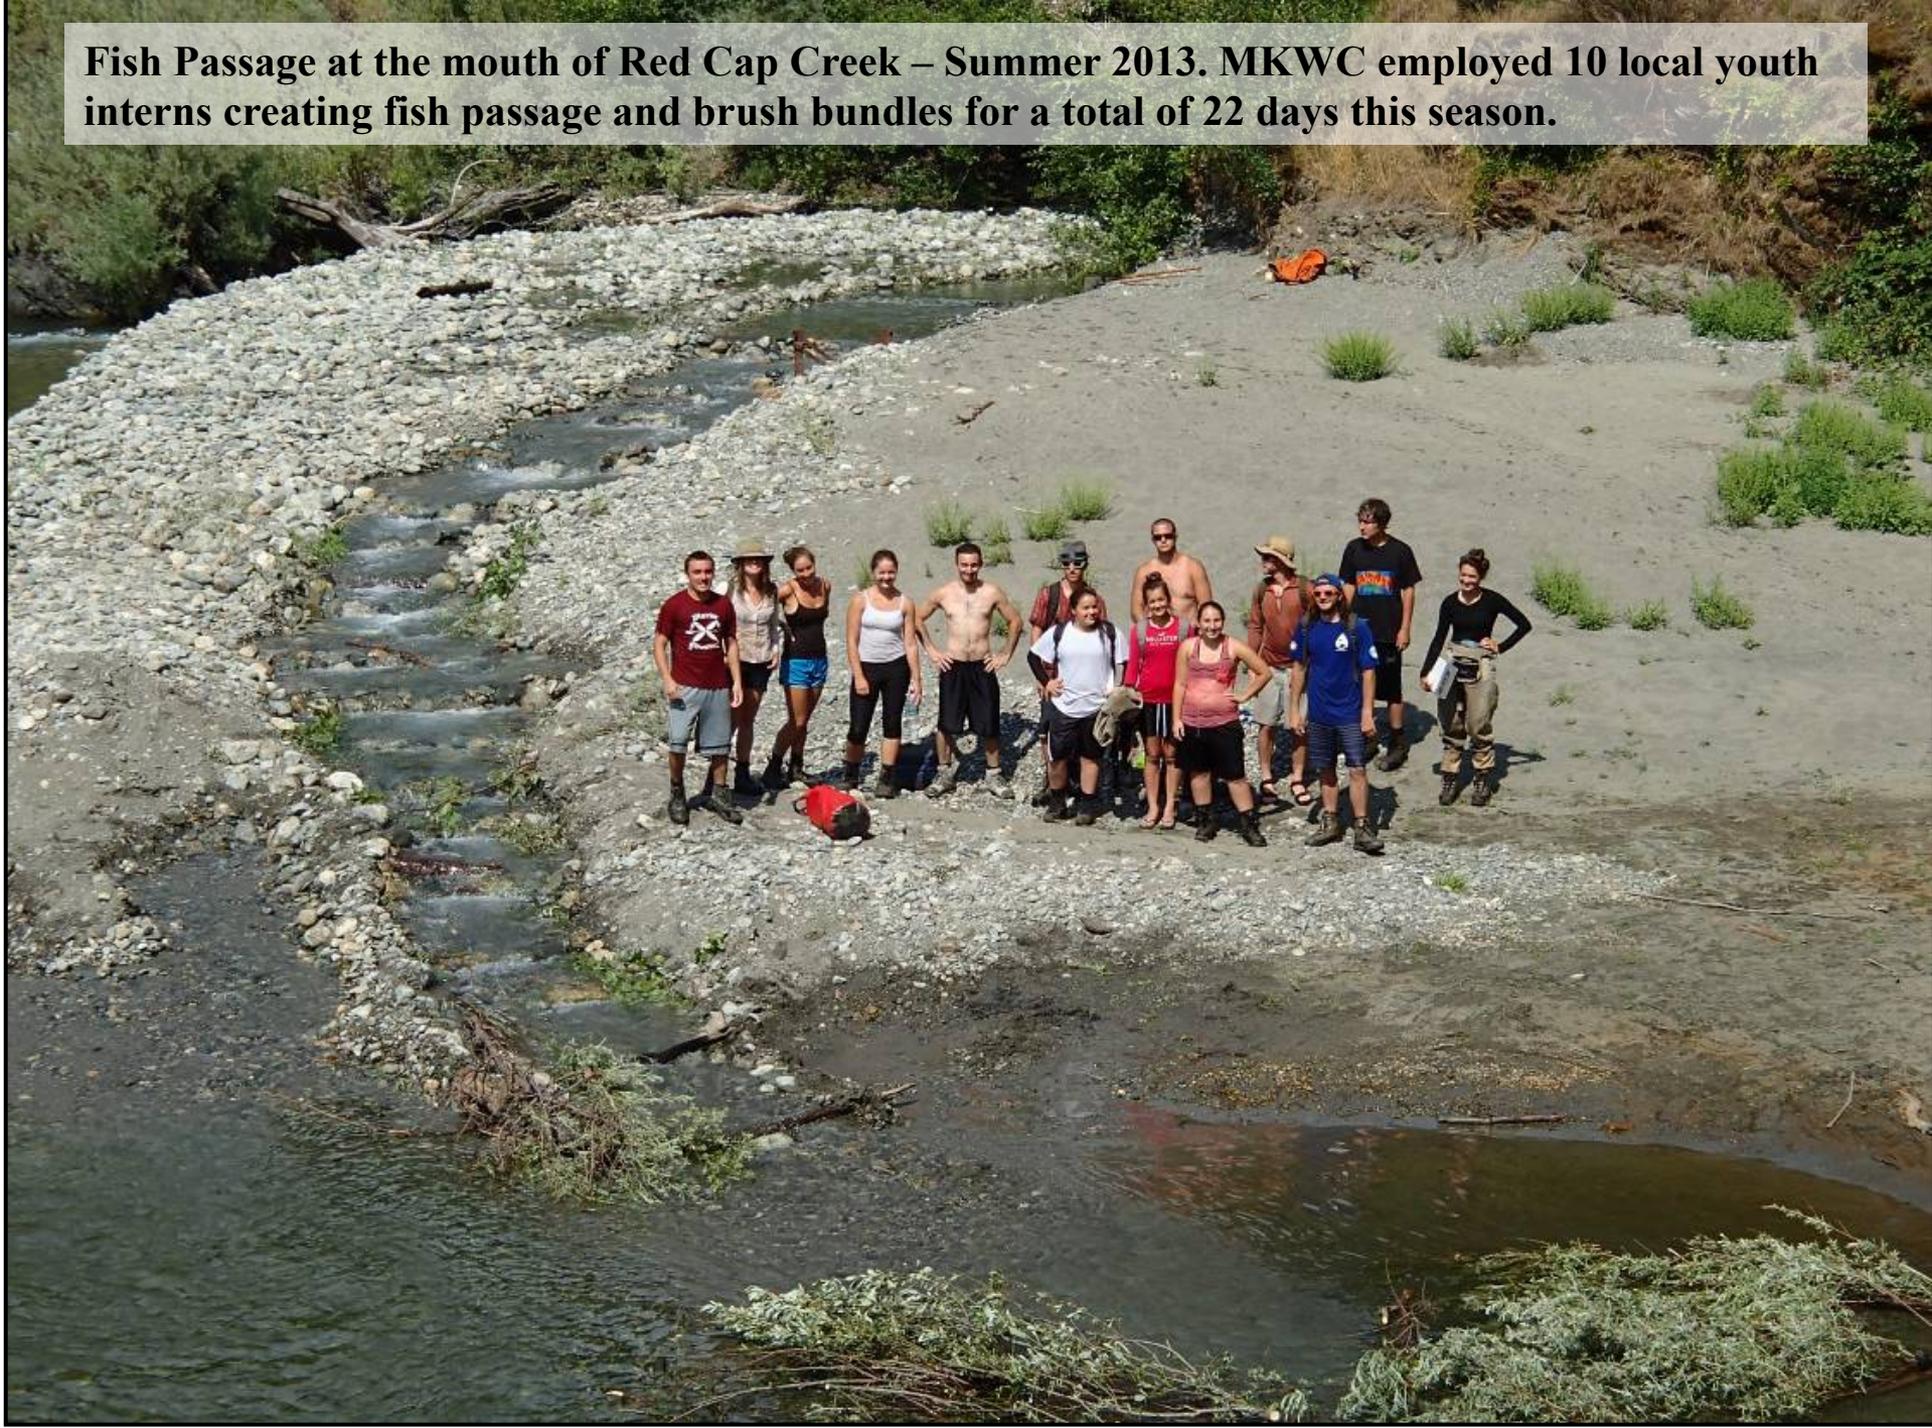
Fish Passage at the mouth of Red Cap Creek – Summer 2013. MKWC employed 10 local youth interns creating fish passage and brush bundles for a total of 22 days this season.

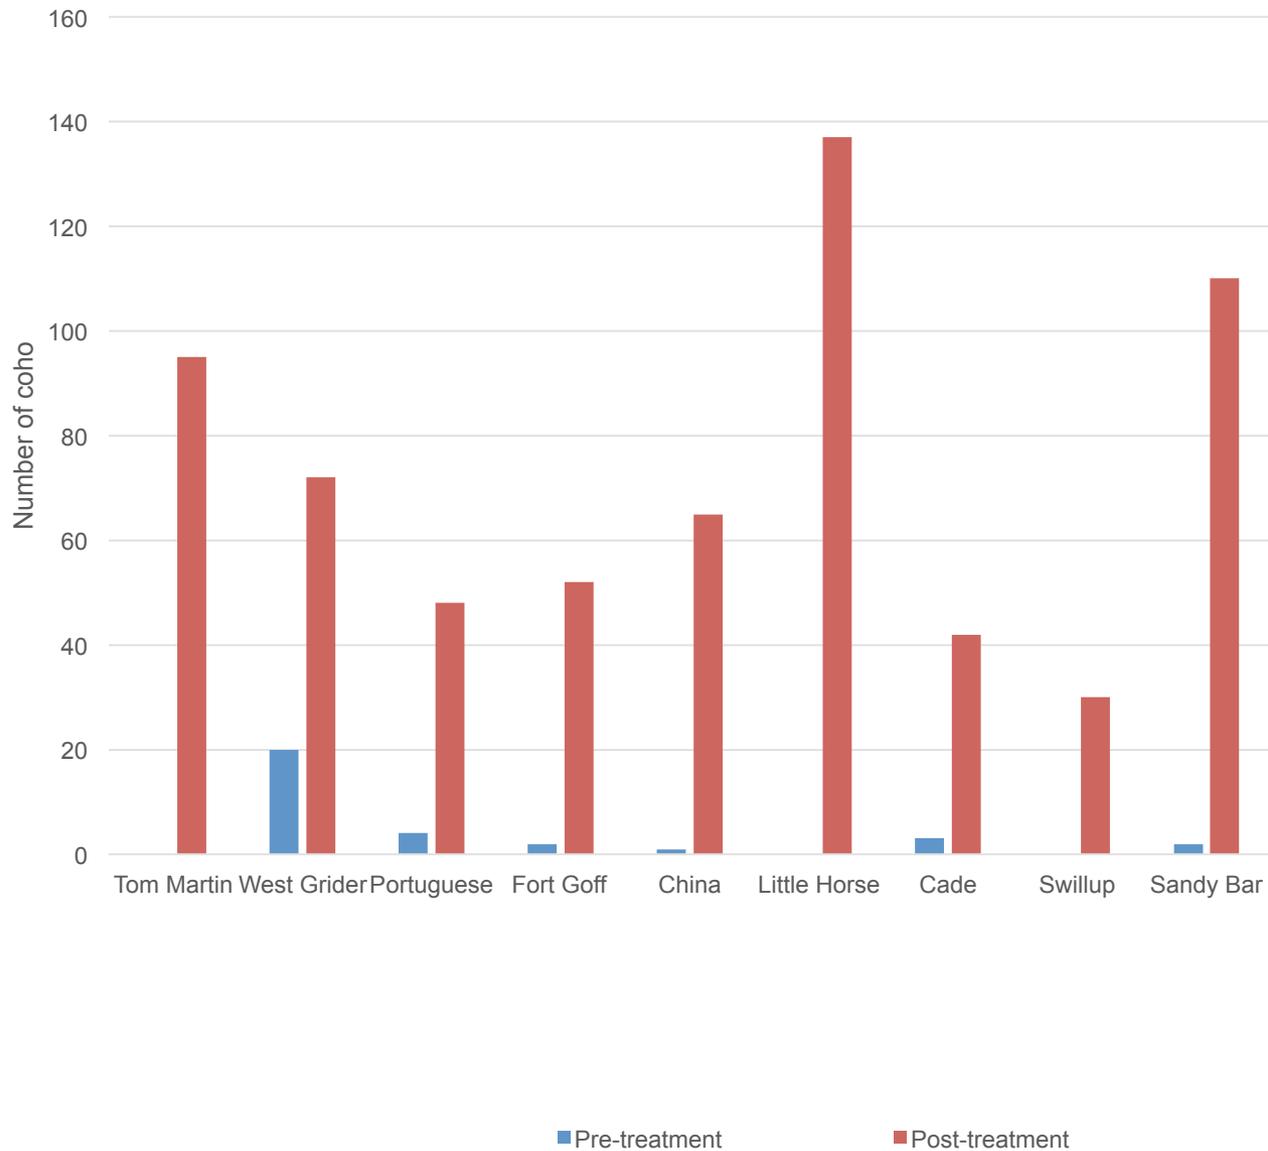
Number of Coho Present Above Barriers Before and After

- MKWC and partners manually treated 65 identified juvenile salmon migration barriers on 47 of 75 assessed tributaries. In addition, 19 tributaries were treated for adult fish passage issues in the fall.
- Of the 47 treated tributaries, 42 were monitored before and after treatment for salmonid presence above and below treated barriers.

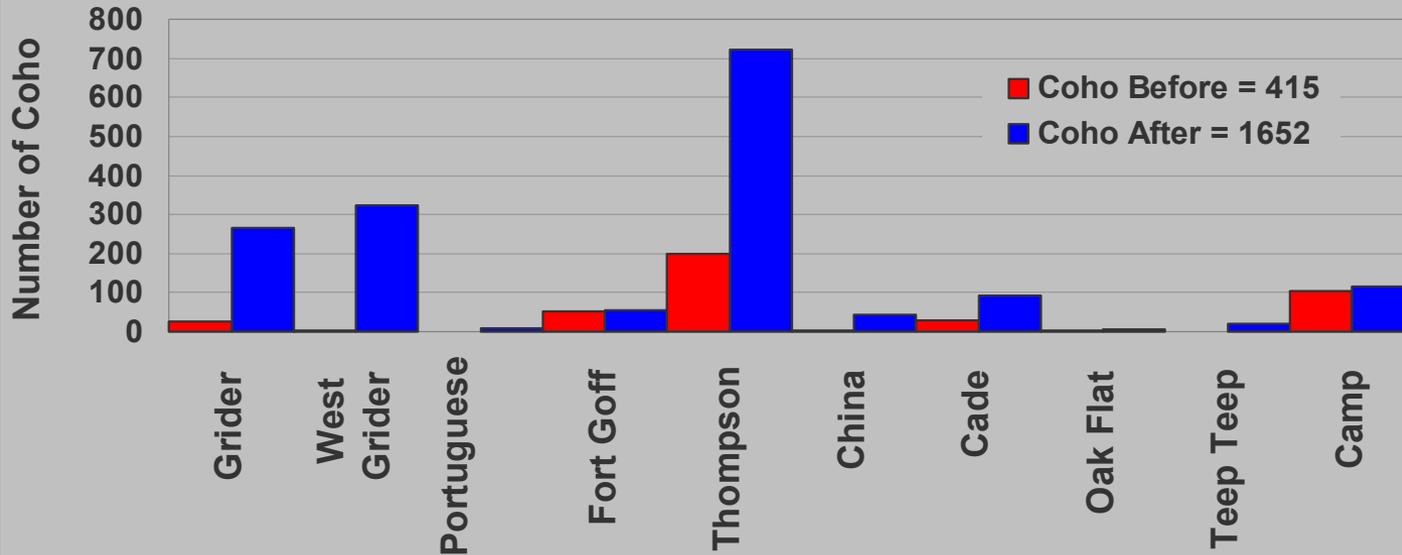
Monitoring Results Above Treated Barriers 2012

Tributary	Date Assessed	Coho Before	Date Monitored	Coho After
Grider Creek	6/28/2012	25	8/14/2012	267
West Grider Creek	6/1/2012	3	8/14/2012	324
Portuguese Creek	6/5/2012	0	8/1/2012	10
Fort Goff Creek	7/1/2012	51	8/1/2012	55
Thompson Creek	7/10/2012	200	8/1/2012	721
China Creek	6/20/2012	2	8/2/2012	43
Cade Creek	7/4/2012	28	8/2/2012	91
Oak Flat Creek	7/10/2012	3	8/2/2012	6
Teep Teep Creek	7/2/2012	0	8/9/2012	20
Camp Creek	7/12/2012	103	8/6/2012	115
Totals:		415		1652

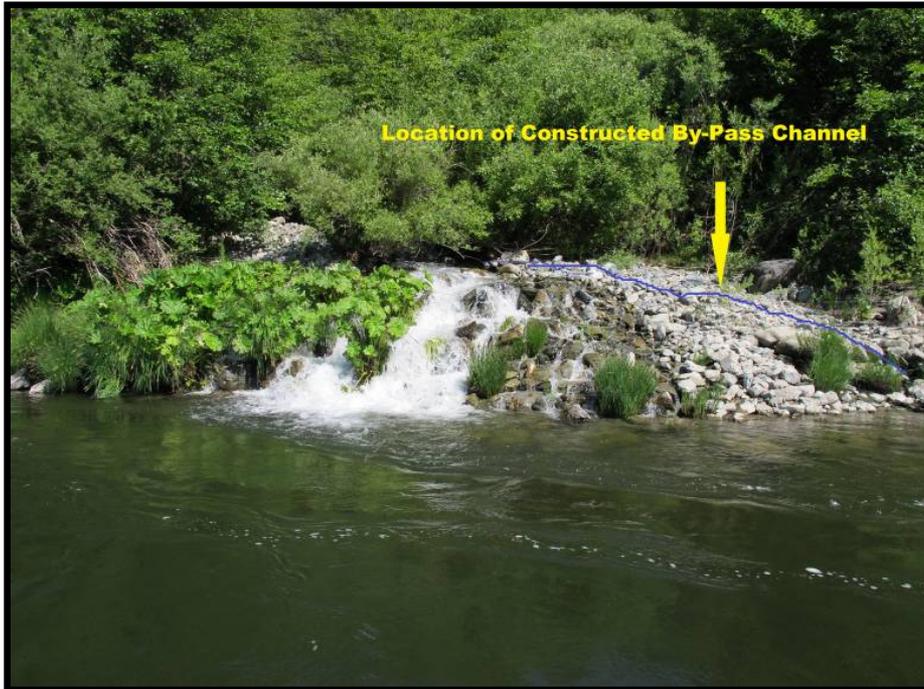
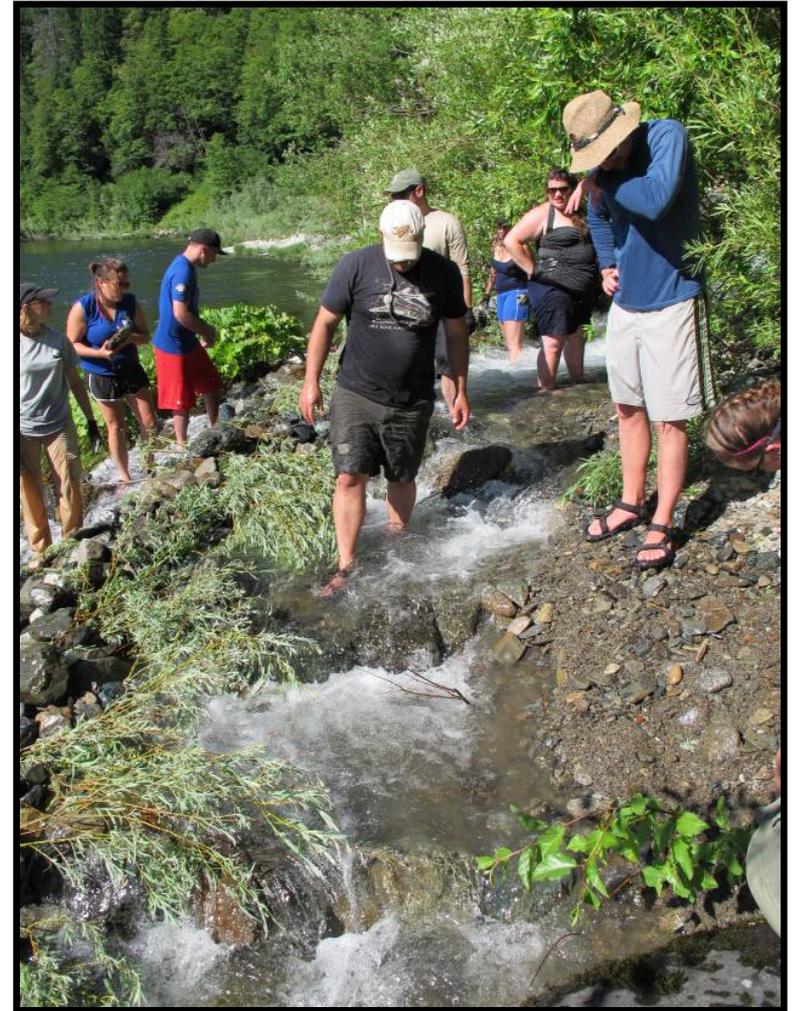
Rodgers Creek – Before and After

In 2010, MKWC and KTFP crews created a low gradient step and pool fishway, bypassing a 15 foot cascade at the mouth of Rodgers Creek.(top). In June of 2012, the Americorps Watershed Stewards Project ,along with MKWC and KTFP staff, worked to maintain passage in this new channel during a weeklong training on the Klamath River (left). Six Chinook redds were counted above the barrier in the Fall of 2012.

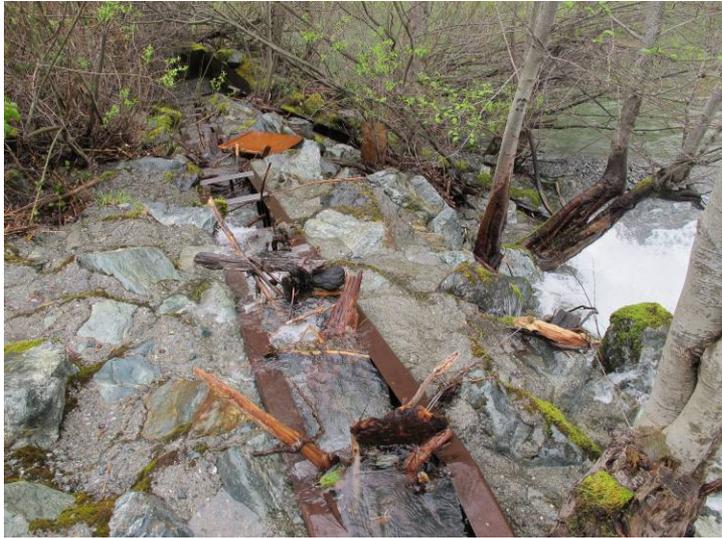
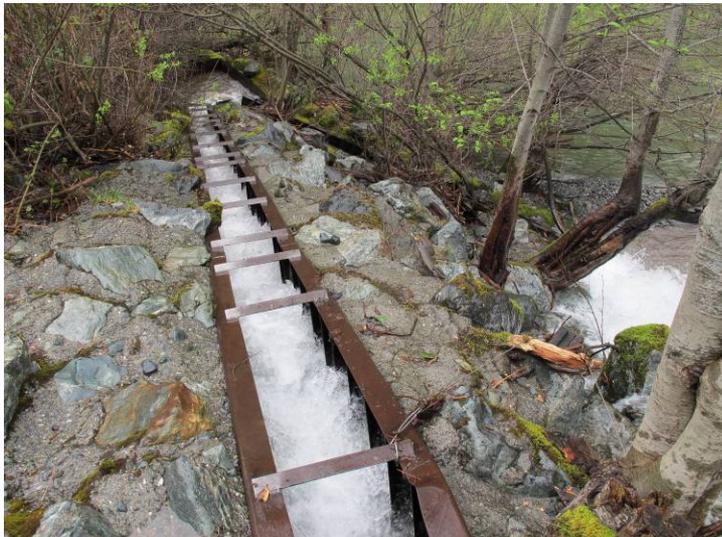
Coon Creek Fish Ladder – Before and After

- **Coon Creek was noted as a productive steelhead stream prior to the Highway 96 construction and culvert installation.**
- **CDFW identified the culvert as a barrier as early as 1934, and in 1977 the fish ladder (left) was installed in lieu of a bridge replacement.**
- **MKWC regularly clears the ladder of debris, and when flows permit MKWC monitors for steelhead spawning above the culvert.**

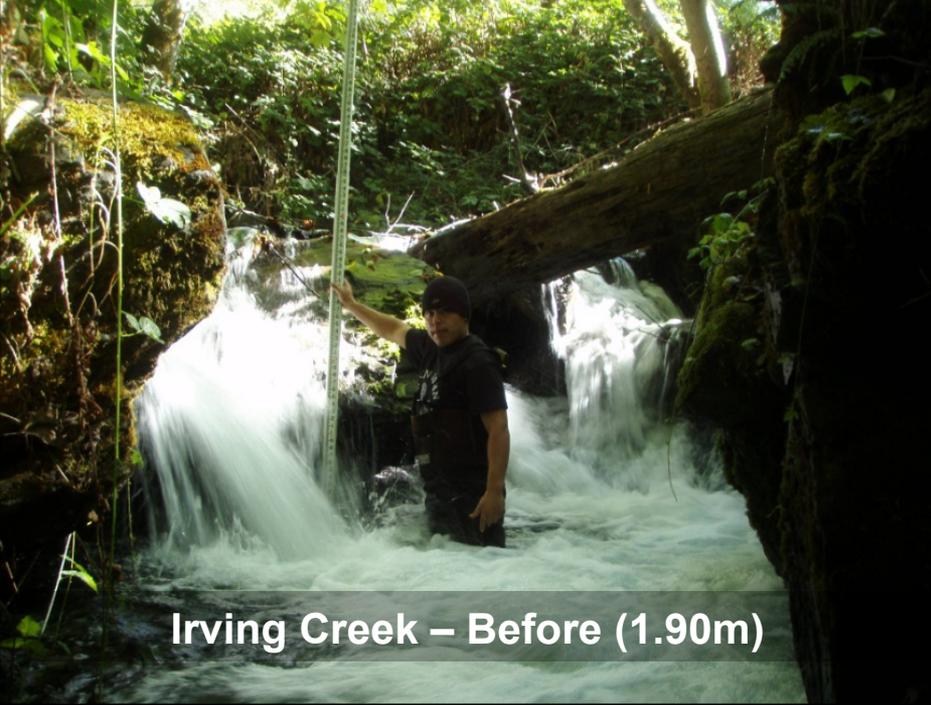
Irving Creek – Before (1.90m)

Boulder Cascade on Irving Creek

- Barrier formed in 2006 flood event
- 10 Fall Chinook redds documented upstream after treatment in 2007

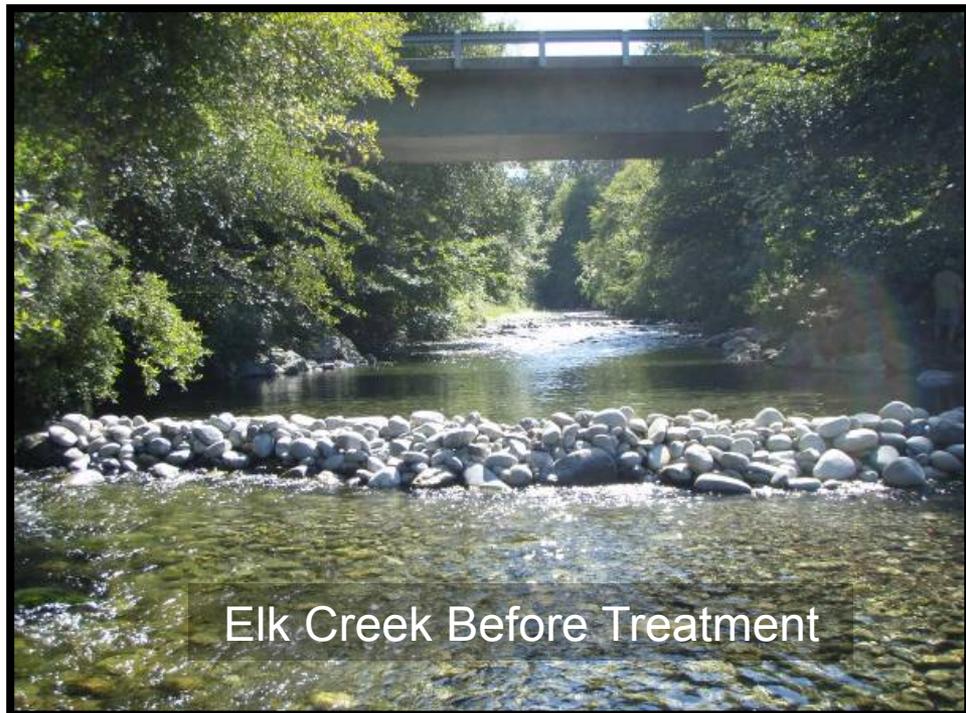
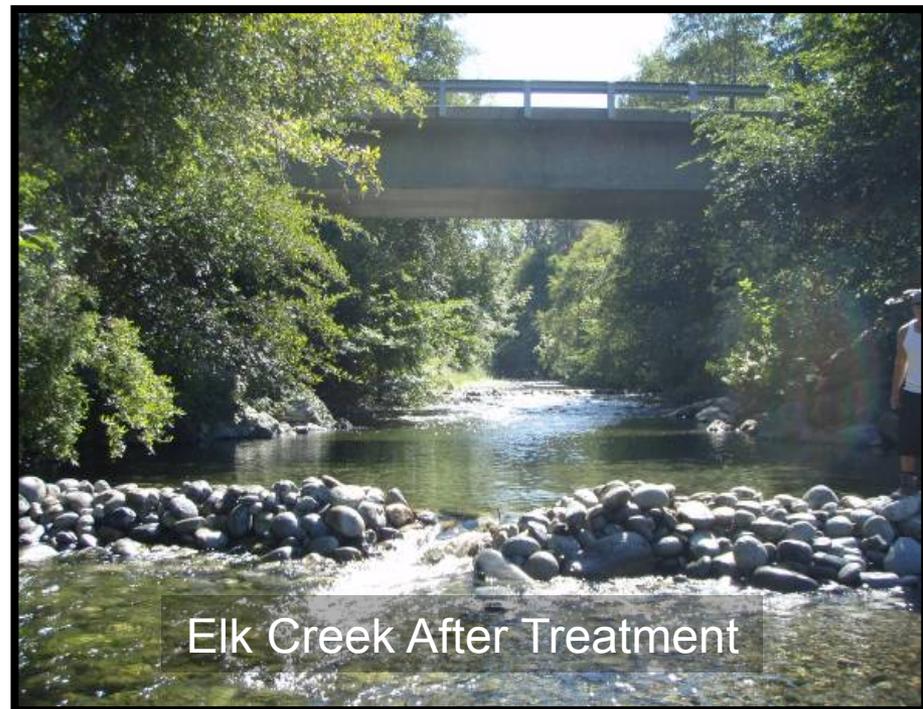
Swimmer's dams and dams constructed during wildfires for drafting cause recurring blockages to fish passage on several key anadromous tributaries, such as Walker Creek, Elk Creek, Indian Creek, Portuguese Creek, Fort Goff Creek, Seiad Creek, etc. By monitoring tribs throughout the summer, MKWC can address these barriers as they arise.

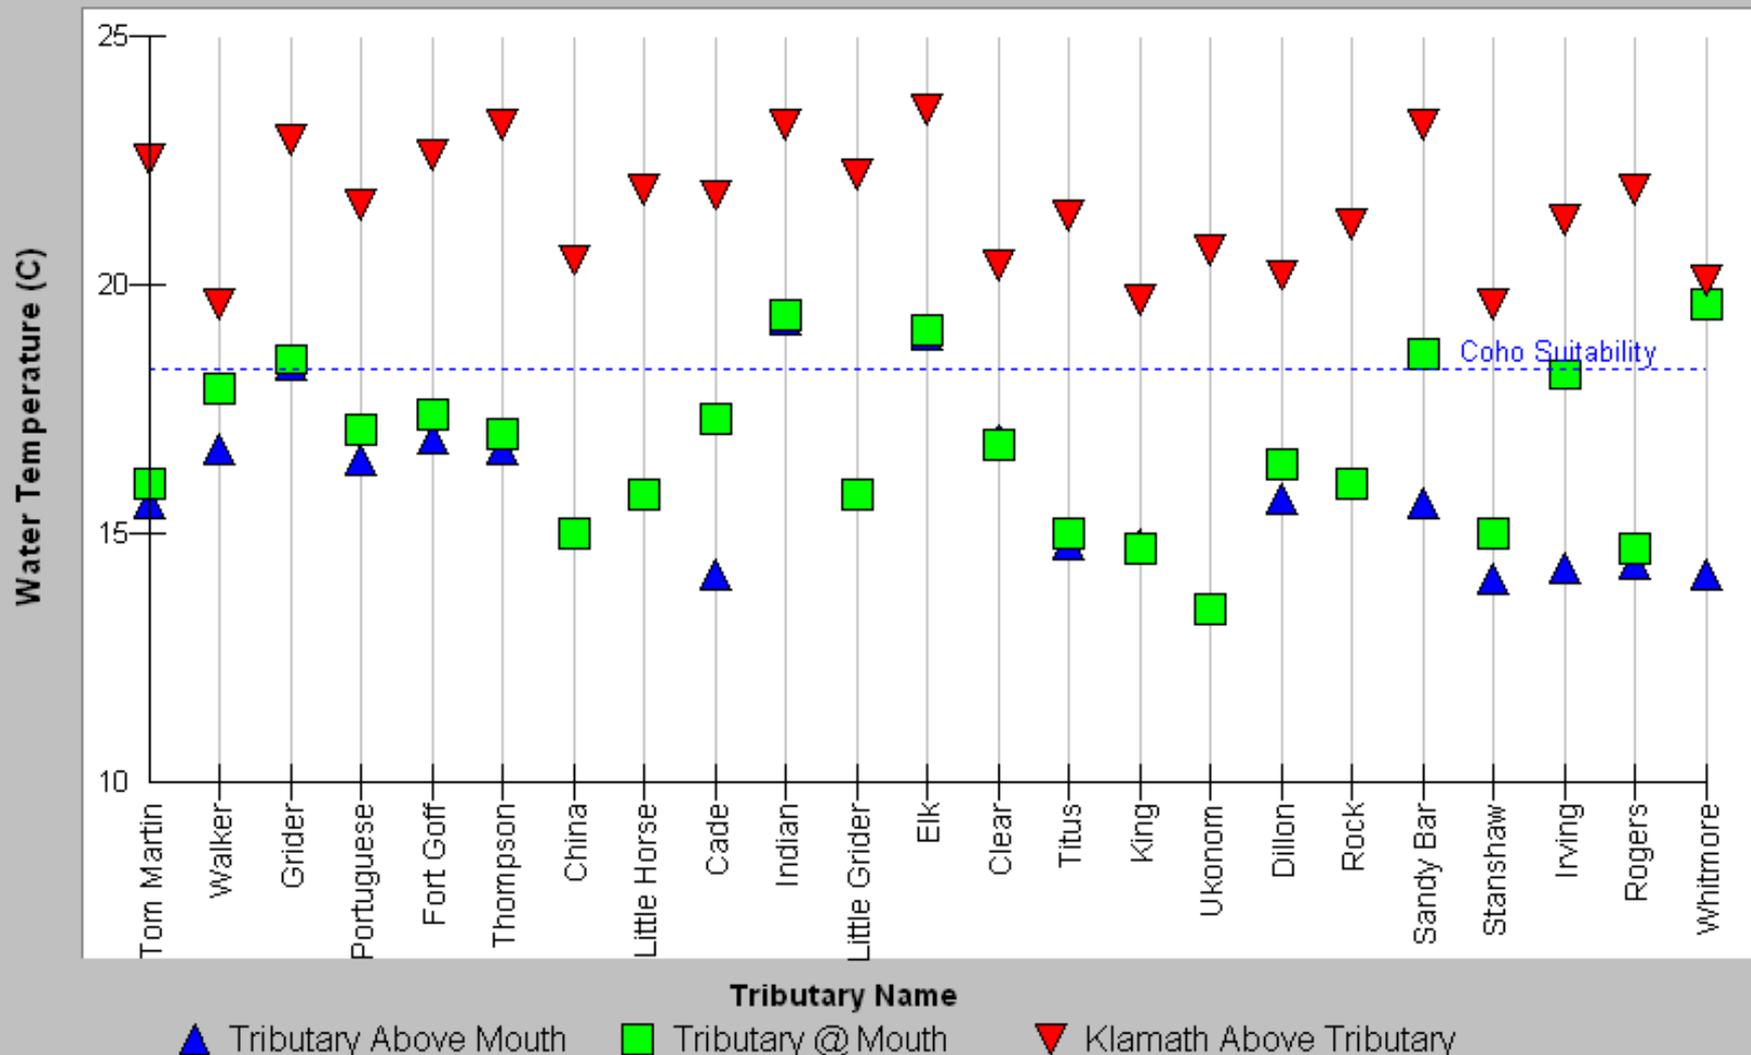
Middle Klamath Tributary and Mainstem Klamath River Temperatures 2006

As tributaries flow across the Klamath floodplain, they can warm up, causing fish to miss potential refugial habitat just upstream. By concentrating flow, we have been able to decrease creek temperatures at their confluence with the Klamath River by as much as 6°C.

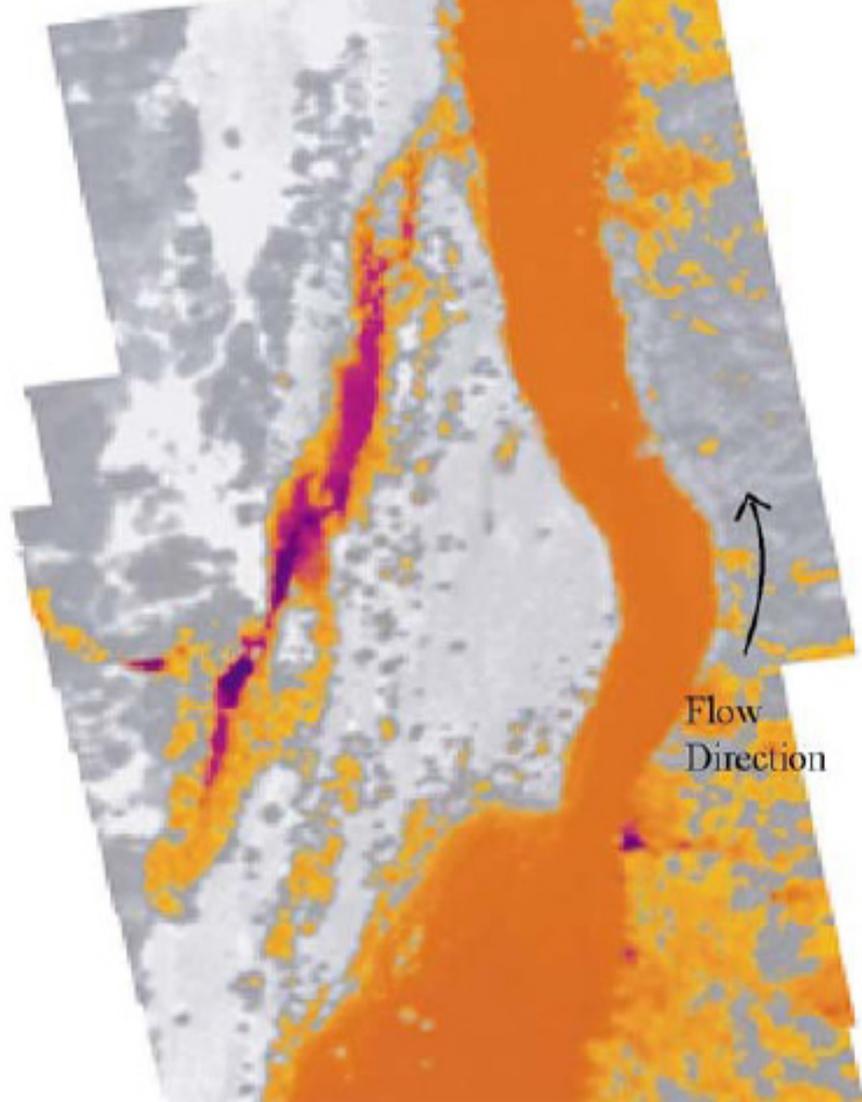
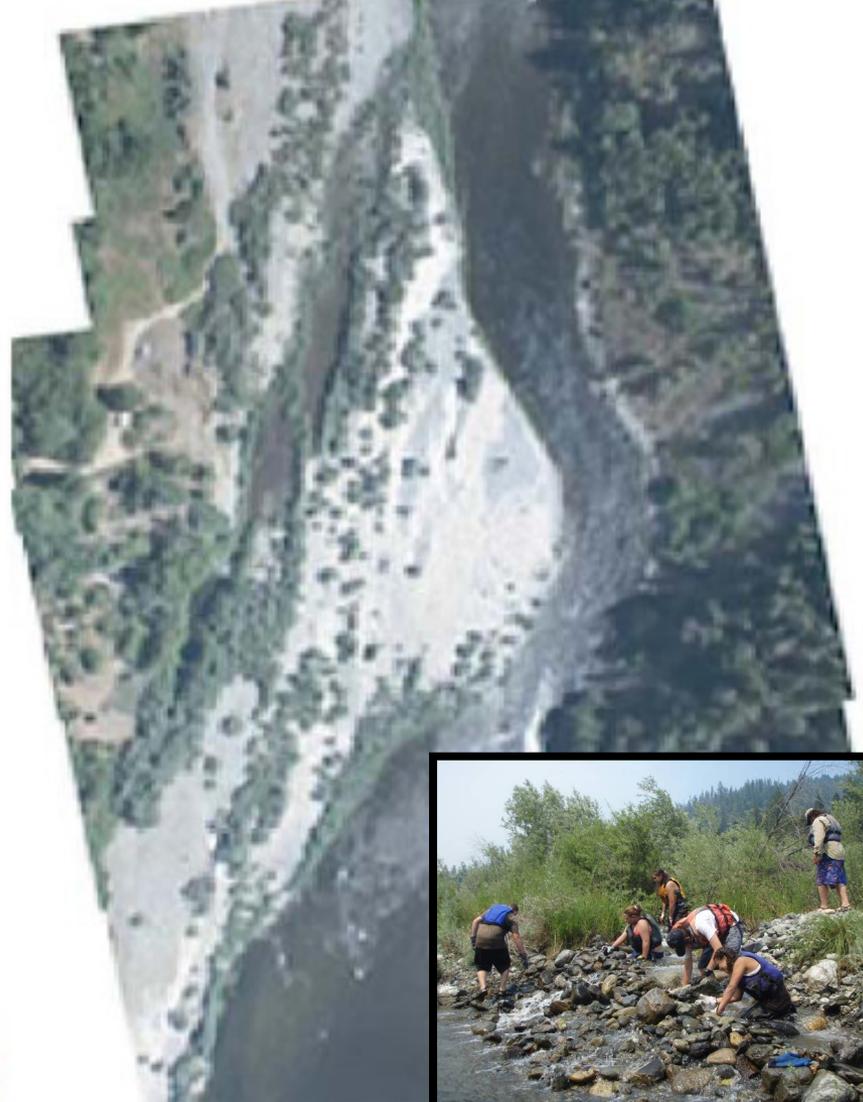
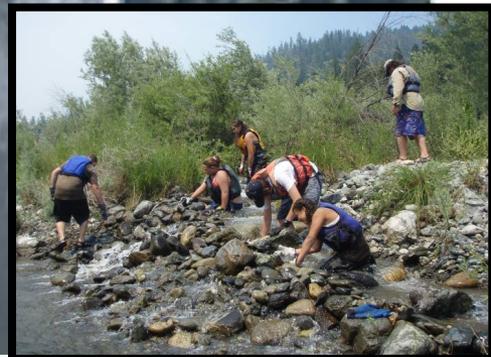
Sandy Bar Creek is hotter than the Klamath at their confluence. By concentrating flows and making a step pool fishway over the alluvial bar, MKWC and partners have maintained access to over 1,500 feet of high quality juvenile coho rearing habitat in the lower reach of the creek.

TIR Image Temperature Scale (deg C)
