Dunn Creek Fish Passage Project Effectiveness Monitoring

California Fish Passage Forum

Barrier Removal Effectiveness Monitoring

Project Title: Dunn Creek Fish Passage Project

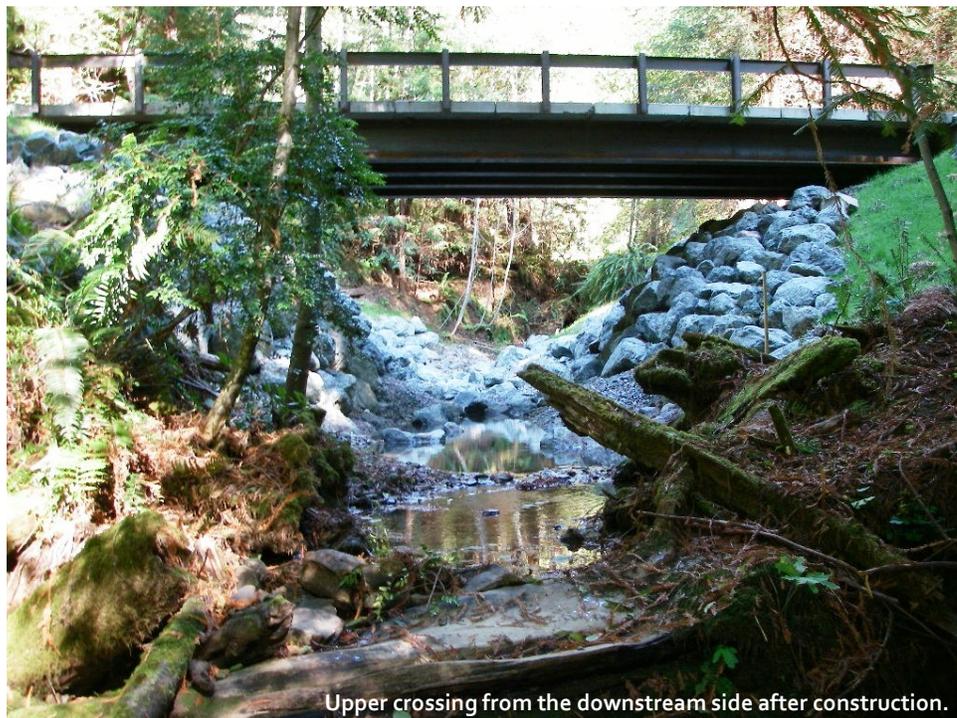
Upper crossing from the downstream side after construction.

- A 36-inch diameter culvert located 60-feet south of the lower bridge crossing was removed and the tributary stream was rerouted through a newly constructed side channel with two boulder weirs.
- An 8-foot diameter culvert at the middle crossing was removed and replaced with a 16-foot wide by 40-foot long bridge.
- A 7-foot diameter culvert at the upper crossing was removed and replaced with a 16-foot wide by 50-foot long bridge.
-

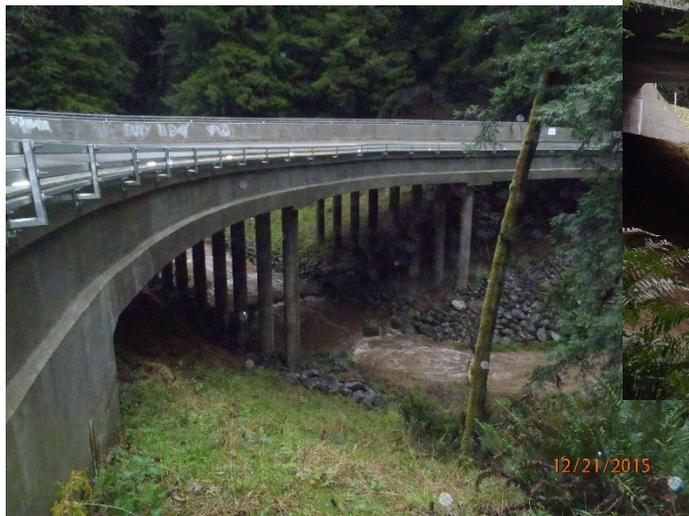
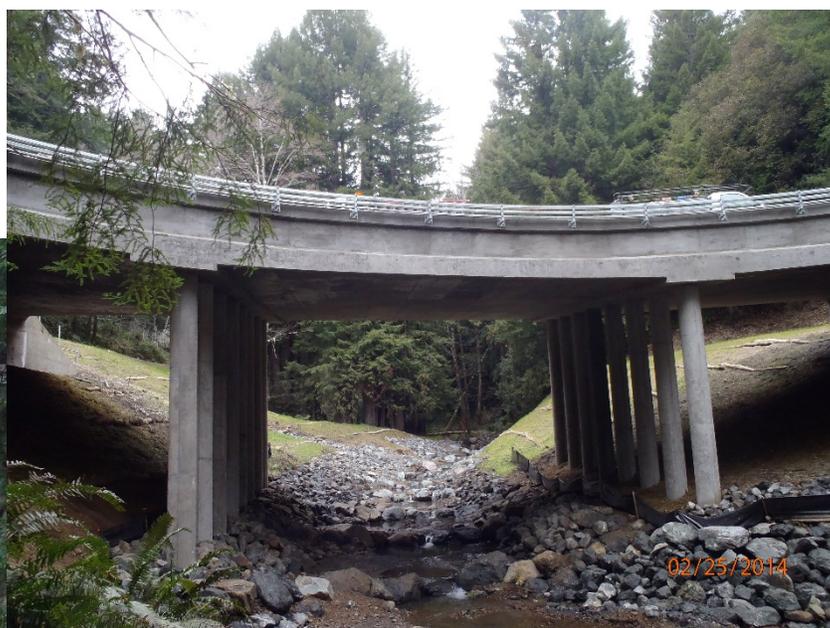
The 134-foot slab bridge (top photo) replaced a nine-foot steel plate pipe culvert that created a six-foot vertical drop and barrier to fish passage downstream. Photo credits: Caltrans (top).

All three culvert upgrade sites (Figures A–F) are located upstream of another site and fish passage barrier remediation project along CA-1 that improved passage conditions for juvenile and adult salmon and steelhead in 2013. The site had a nine-foot diameter steel plate pipe culvert that created a six-foot vertical drop and barrier to fish passage downstream. The culvert was removed and replaced with a 134-foot long concrete slab bridge.

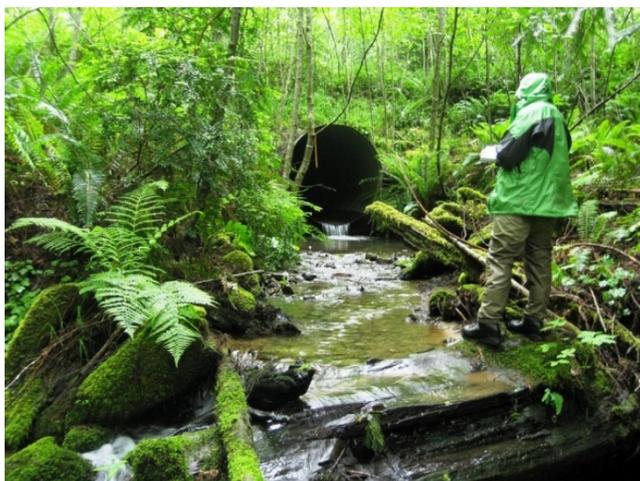
A. Upper crossing before construction.

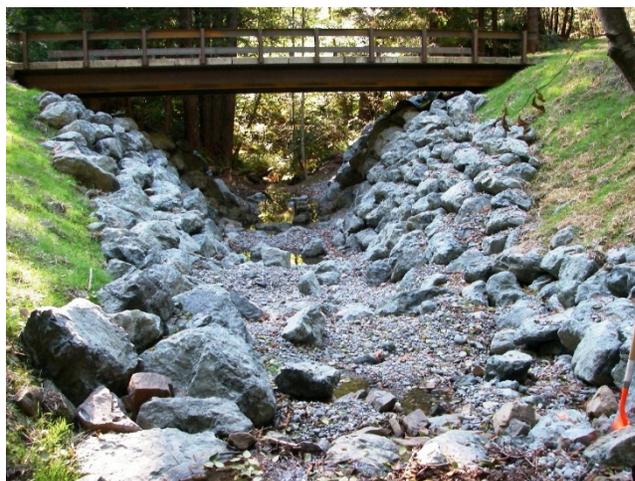
B. Upper crossing after construction.

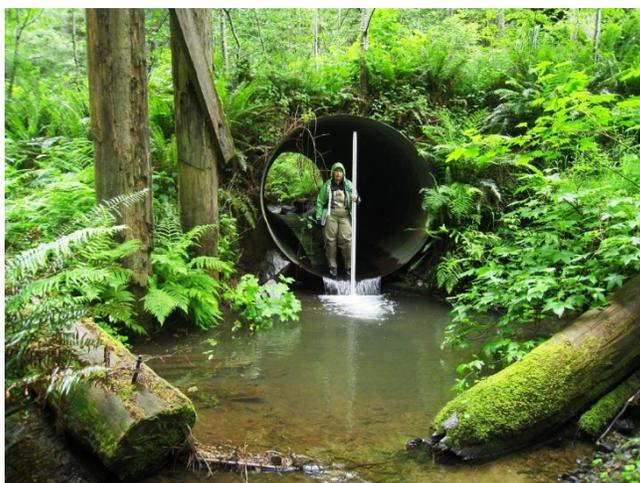
C. Middle crossing before construction.

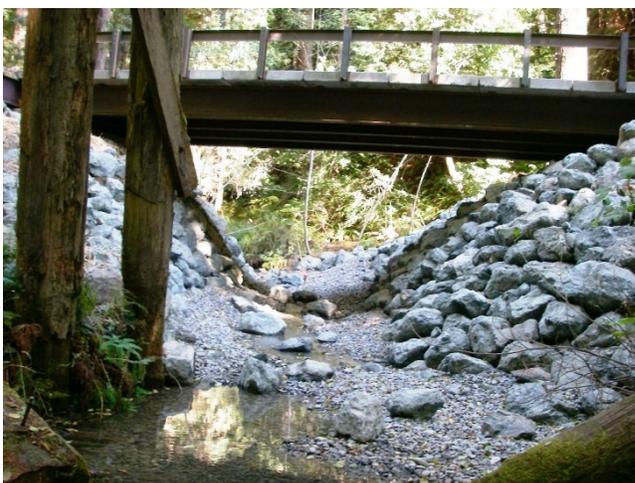
D. Middle crossing after construction.

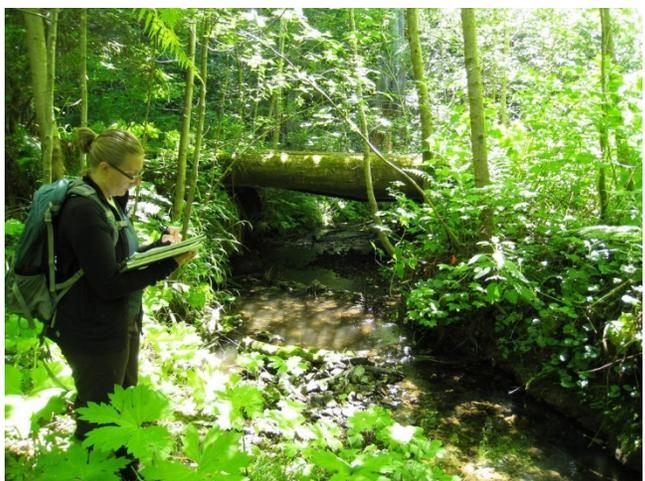
E. Lower crossing before construction.

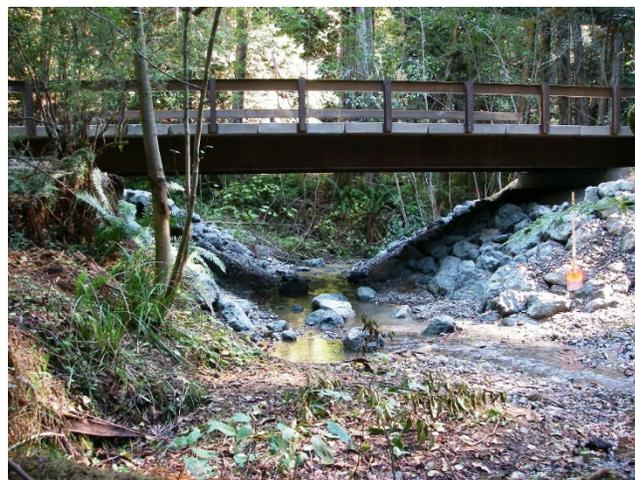
F. Lower crossing after construction.
